## Grounding Caption

## Medical Report

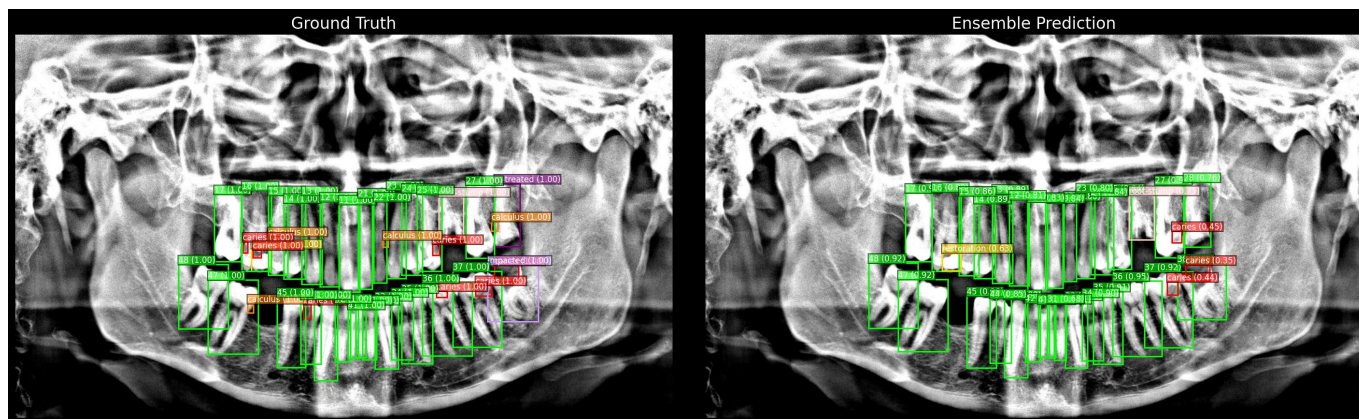
A total of 29 teeth are visualized, with full eruption observed. All detected wisdom teeth (#48, #28, and #38) are present and non-impacted. No significant anatomical anomalies or missing teeth are noted.

- Suspicious for a root stump near tooth #25.
- Areas of concern noted for suspected caries near tooth #27.
- Areas of concern noted for suspected caries near tooth #37.
- Areas of concern noted for suspected caries near tooth #38.

A restoration is present near tooth #16.

- The suspicious root stump near #25 warrants evaluation for possible residual root fragments or infection.
- Suspected caries near posterior teeth (#27, #37, #38) require confirmation via additional imaging or clinical assessment to determine extent and treatment urgency.

- Reinforce oral hygiene protocols, emphasizing interproximal cleaning for posterior regions.
- Educate on dietary modifications to reduce caries risk in susceptible areas.

- Schedule a 6-month recall to monitor suspicious caries and root stump.
- Refer to an endodontist for further evaluation of the root stump near #25 if clinical symptoms arise.
- Consider targeted radiographic imaging (e.g., bitewing) to clarify caries status in #27, #37, and #38.
