Grounding Caption

Oral Panoramic X-ray Examination Report

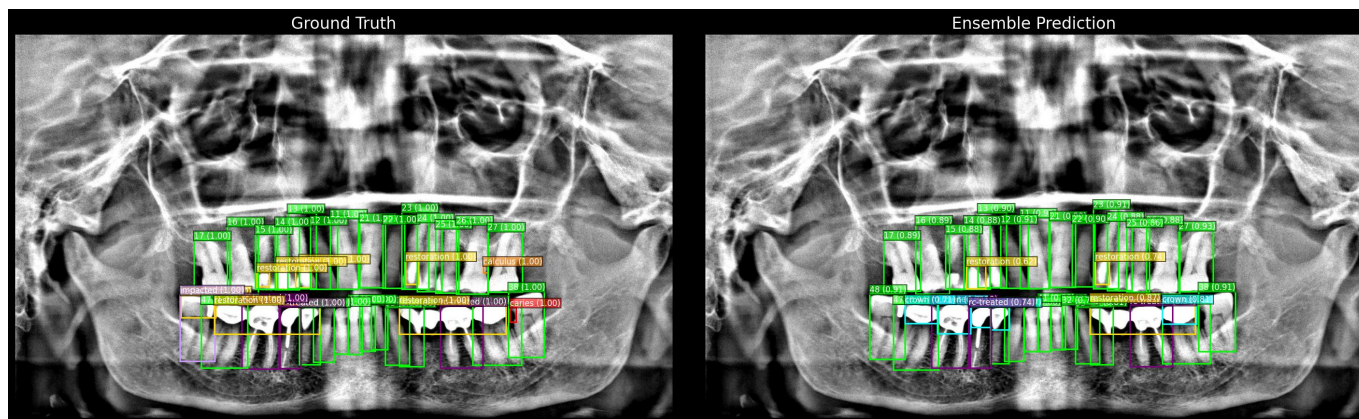
A total of 26 teeth are visualized within the panoramic field. All four wisdom teeth (*#48 and #38*) are present and non-impacted. The remaining dentition appears fully erupted, with no evidence of gross anatomical displacement or congenital absence.

No active pathological conditions, including caries, periapical radiolucencies, or retained roots, are identified. No signs of periodontal pathology or impacted teeth are observed.

- Crown:** Present on #44.
- Restoration:** Detected near tooth #23 and #34.
- Root canal-treated (RC-treated):** Evidence of RC treatment near tooth #37 and #44.
- Crown:** Additional crowns noted near tooth #47 and #44.
- Restoration:** Minor restoration near tooth #14.

- No urgent pathological conditions identified.
- Historical interventions (crowns, restorations) are noted but do not require immediate intervention.

- Reinforce oral hygiene practices to maintain periodontal health.
- Continue regular monitoring of restored teeth (#23, #34, #14) and RC-treated areas (#37, #44) for secondary caries or structural compromise.

- **6-month recall** for routine evaluation of periodontal and restorative status.
- Annual panoramic imaging recommended to assess stability of historical interventions and detect early signs of pathology.
- Patient counseling on dietary habits and home care to preserve existing restorations and prevent future caries.
