## Grounding Caption

## Medical Report

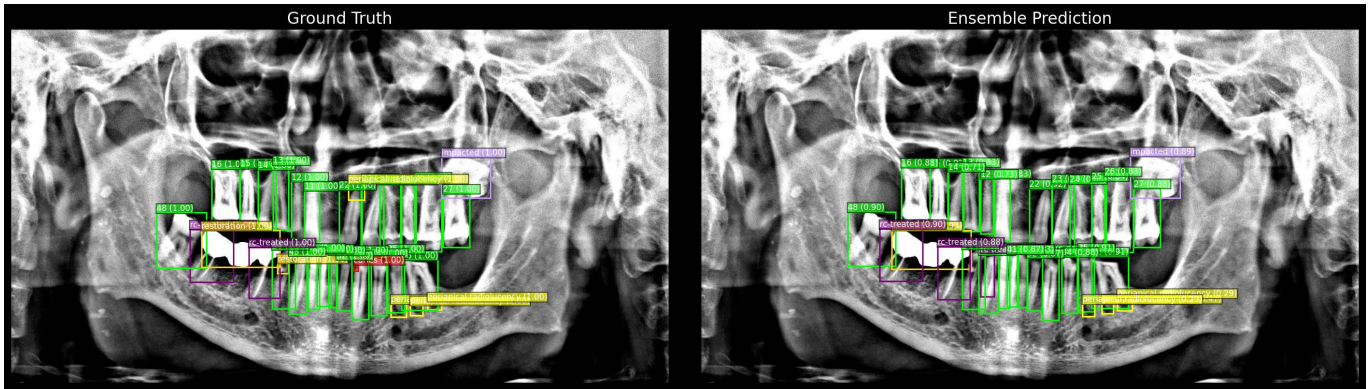
A total of 23 teeth were visualized with clear center points in both arches. Wisdom teeth showed reduced visibility; only the right mandibular wisdom tooth (#48) was clearly identified as non-impacted and fully erupted.

- Clear indication of an impacted tooth structure near #27.
- Suspicious areas of concern for periapical radiolucency noted near #36 (two distinct regions) and #35. These findings require corroboration with additional imaging.

- Presence of root canal-treated structures near #44 and #48.
- Definitive restoration material identified near #44.

- Impacted tooth near #27 necessitating evaluation for surgical extraction or orthodontic planning.
- Suspected periapical pathology near #36 and #35; potential endodontic compromise requires confirmation via CBCT.

- Reinforce periodontal care for #27 to mitigate secondary caries risk.
- Monitor #35 and #36 for radiographic progression with 3-month follow-up imaging.

- Immediate referral to an endodontist for assessment of periapical radiolucency near #36.
- 6-month recall for tracking impacted #27 and suspicious periapical lesions.
- Evaluate root canal-treated #44 for potential restoration replacement or apical surgery.
