Grounding Caption

This localization caption provides multi-dimensional spatial analysis of anatomical structures and pathological findings for this panoramic dental X-ray image, including:

Medical Report

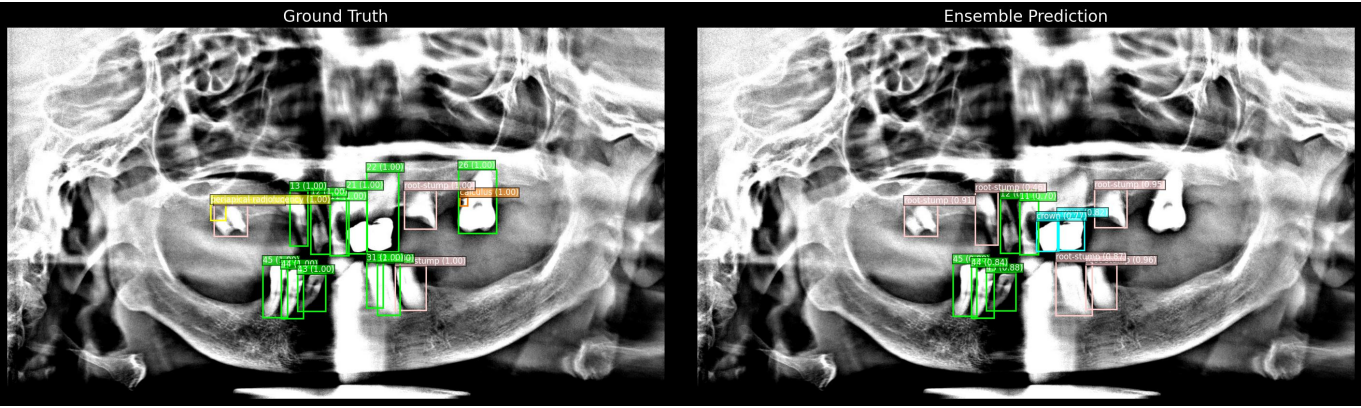
A total of five teeth are visualized in the panoramic image, corresponding to FDI numbers #11, #12, #43, #44, and #45. No wisdom teeth (third molars) are detectable in the field of view.

- Clear indication of root stumps near tooth #11 (buccal/lingual aspect) and near tooth #45.
- Suspicious areas of concern for residual root stumps adjacent to tooth #12.
- Evidence of root stumps near tooth #43 with high confidence.
- Areas of concern noted for possible residual root fragments near tooth #12 requiring further evaluation.

Presence of two dental crowns positioned near tooth #11, consistent with prior restorative treatment.

- Root stumps identified near teeth #11, #43, and #45 suggest prior extraction(s) or incomplete root resorption.
- Suspicious radiopaque structures adjacent to tooth #12 warrant investigation for residual root fragments or calcified lesions.

- Reinforce oral hygiene protocols to minimize periodontal complications in areas adjacent to root stumps.
- Monitor for signs of infection (e.g., radiolucency, swelling) near residual root fragments.

- Referral to an endodontist or periodontist for evaluation of root stumps near teeth #11, #43, and #45.
- Immediate clinical examination of the suspicious area near tooth #12 to confirm or rule out calcified lesions.
- 6-month recall for panoramic imaging to assess stability of residual structures and monitor for pathologic changes.
