Grounding Caption

Medical Report

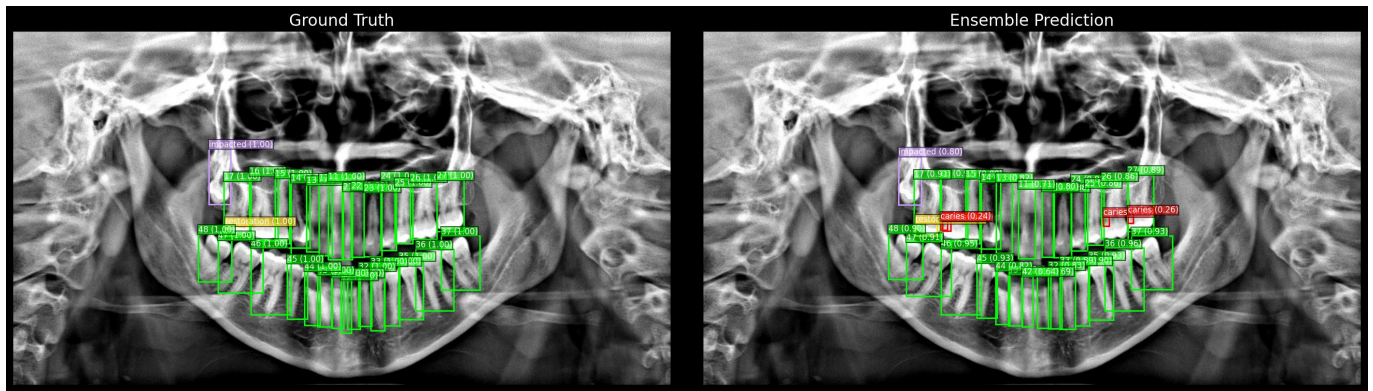
Teeth visibility with center points (total: 26):

Wisdom teeth detection (total: 1):

Dental Pathological Findings (total: 5):

Historical Treatments (total: 1):

- A total of 26 teeth are visualized within the panoramic image. All identified wisdom teeth are accounted for, with #48 (left mandibular third molar) present and non-impacted. Remaining wisdom teeth (#18, #28, #38) are not clearly visualized or not included in the dataset.

- **Impacted wisdom tooth:** Clear indication of an impacted wisdom tooth near #17 (right maxillary second molar).
- **Suspected caries:** Areas of concern noted for potential carious lesions near #16 (left maxillary first molar) and adjacent to #25 (right mandibular first premolar) and #26 (right mandibular second premolar). Confidence in these findings is low, necessitating clinical correlation.

- **Restoration:** Presence of a dental restoration near #17 (right maxillary second molar).
-

- Impacted wisdom tooth near #17 requires evaluation for surgical extraction due to risk of periodontal compromise or caries propagation.
- Suspected carious lesions near #16, #25, and #26 demand urgent clinical assessment to confirm diagnosis and initiate preventive or restorative management.

- Reinforce oral hygiene protocols, emphasizing interproximal cleaning around #16 and #25.
- Monitor suspicious areas near #16, #25, and #26 with 3-month follow-up imaging to assess lesion progression.

- **Referral:** Urgent consultation with an oral surgeon for impacted wisdom tooth (#17) and an endodontist for definitive evaluation of suspected caries near #16.
- **Recall:** Schedule a 6-month recall for reassessment of carious lesions and impacted tooth status.
- **Imaging:** Repeat high-resolution imaging for #25 and #26 to clarify caries extent if clinical findings remain inconclusive.
