## Grounding Caption

# Medical Report

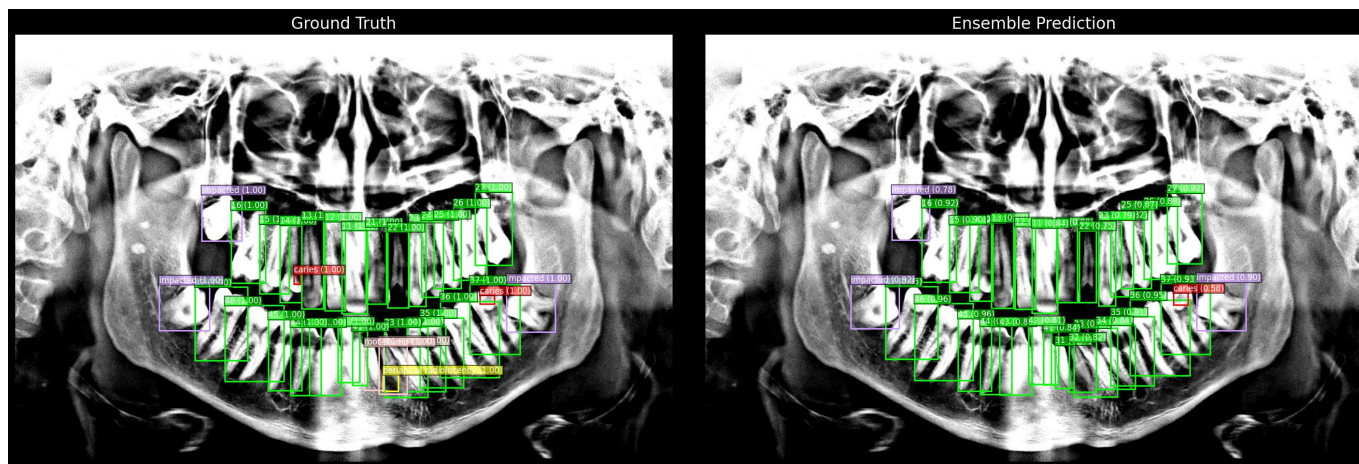
A total of 27 teeth were visualized in the panoramic image. No wisdom teeth (third molars) were detected bilaterally.

- Clear indication of impacted tooth near #47 (lower left first molar).
- Impacted tooth noted near #37 (lower right first molar).
- Suspicious for impacted tooth near #16 (upper left first molar).

- Suspicious for caries near #37 (lower right first molar).

No prior dental treatments, restorations, or implants were observed.

1. Impacted tooth near #47 requires surgical evaluation for potential removal.
2. Impacted tooth near #37 may necessitate orthodontic or surgical intervention.
3. Suspicious caries near #37 warrants further imaging (e.g., periapical radiograph) to confirm extent.
4. Impacted area near #16 (low confidence) should be monitored for changes.
