Grounding Caption

ORAL PANORAMIC X-RAY EXAMINATION REPORT

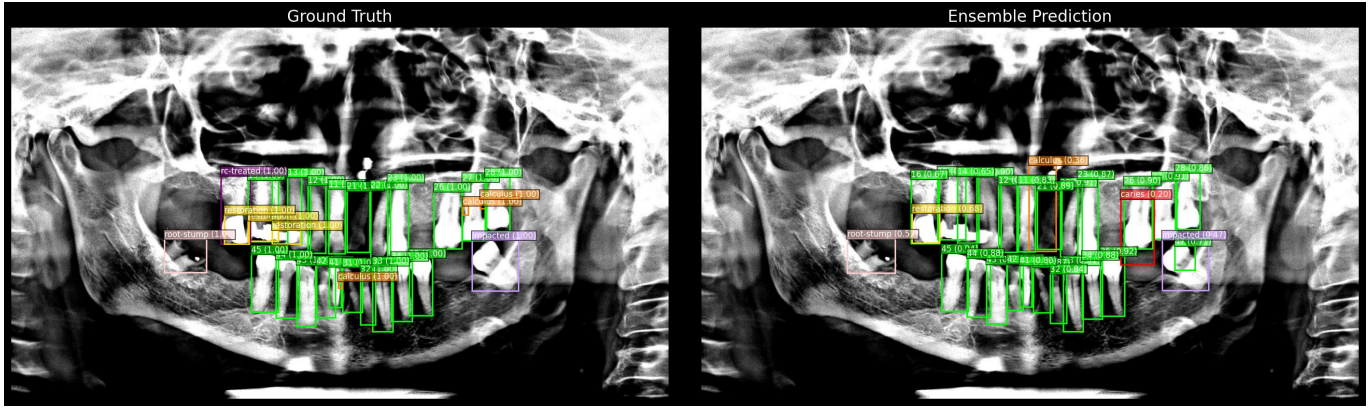
A total of 23 teeth are visualized, with complete eruption of the posterior dentition. Wisdom teeth status: #28 is fully erupted and unimpacted; other wisdom teeth (#18, #38, #48) are not visualized in the field.

1. **#26**: Suspicious for caries with radiolucent demineralization noted in the mesial aspect.
2. **#21**: Area of concern for supragingival calculus accumulation on the lingual surface.
3. **Near tooth #16**: Suspicious for a root stump adjacent to the apical region, consistent with prior extraction remnants.
4. **Near tooth #47**: Area of concern for impacted structure (likely a residual fragment or supernumerary tooth) adjacent to the apical third of #47.

1. **#16**: Presence of a composite restoration with well-defined margins and no evidence of secondary caries.
-

1. **Deep suspicious caries on #26** requiring immediate endodontic evaluation to prevent pulpal involvement.
2. **Impacted structure near #47** necessitating cone-beam CT imaging to assess its relationship with adjacent anatomic structures.

1. Reinforce biofilm control measures for calculus-prone areas (#21).
2. Monitor radiopaque root stump near #16 for signs of resorption or infection.

1. Schedule endodontic referral for #26 within 2 weeks.
 2. Order CBCT imaging for impacted fragment near #47 to guide surgical planning.
 3. 6-month recall for radiographic and clinical monitoring of all suspicious findings.
-
