Grounding Caption

Medical Report

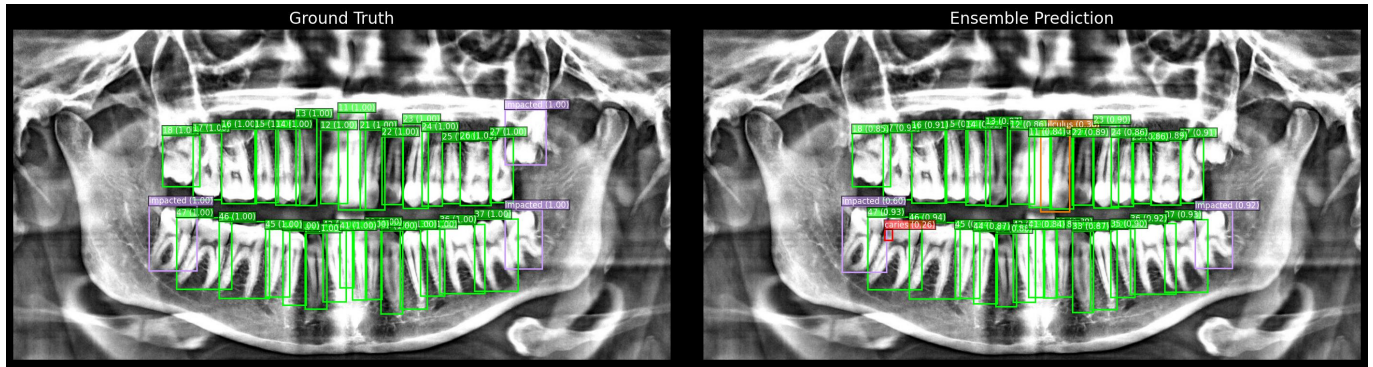
A total of 29 teeth are visualized within the panoramic imaging field. The left lower wisdom tooth (#18) is present and unimpacted. No evidence of other wisdom teeth is noted in the dataset.

- **Tooth #21 (Upper Left Lateral Incisor):** Suspected calculus deposition at the cervical region.
- **Near Tooth #37 (Upper Right First Molar):** Clear indication of an impacted tooth in the vicinity.
- **Near Tooth #47 (Lower Left Second Premolar):** Suspicious for impacted tooth morphology and areas of concern for carious lesions.

No prior restorative, endodontic, or prosthetic interventions observed in the dataset.

- Impacted tooth near #37 requires evaluation for potential surgical exposure or orthodontic management.
- Suspected calculus on #21 and suspicious carious lesion near #47 necessitate confirmation via supplemental imaging or clinical examination.

- Reinforce meticulous interproximal cleaning to mitigate calculus progression on #21.
- Emphasize targeted plaque control near #47 to prevent cariogenic progression.

- Schedule a 6-month recall for reassessment of carious lesions and impacted tooth near #37.
- Referral to an oral surgeon for detailed assessment of impacted teeth near #37 and #47.
- Consider selective scaling to address suspected calculus on #21 if clinically confirmed.
