Grounding Caption

This localization caption provides multi-dimensional spatial analysis of anatomical structures and pathological findings for this panoramic dental X-ray image, including:

Medical Report

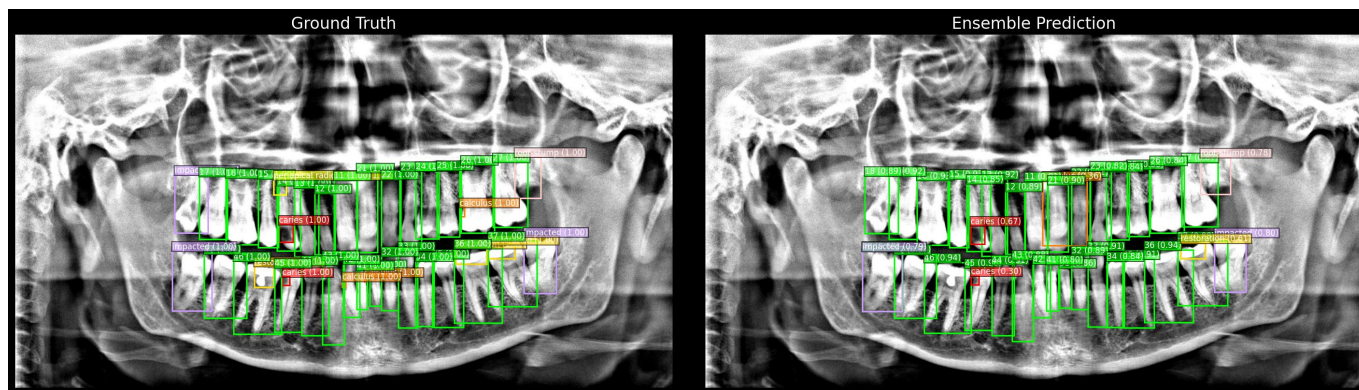
Teeth visibility with center points (total: 30):

Wisdom teeth detection (total: 2):

```
[
{'box_2d': [421, 372, 510, 525], 'tooth_id': '18', 'is_impacted': false, 'score': 0.89},
{'box_2d': [415, 571, 521, 730], 'tooth_id': '48', 'is_impacted': true, 'score': 0.6}
]
```

Dental Pathological Findings (total: 6):

```
[
{'box_2d': [892, 385, 1010, 556], 'tooth_id': '22', 'label': 'calculus', 'score': 0.36},
{'box_2d': [414, 571, 520, 730], 'tooth_id': '48', 'label': 'impacted', 'score': 0.79},
{'box_2d': [1347, 535, 1430, 680], 'tooth_id': 'unknown', 'label': 'impacted', 'score': 0.8, 'near_tooth': '37'},
{'box_2d': [1310, 323, 1390, 421], 'tooth_id': 'unknown', 'label': 'root-stump', 'score': 0.78, 'near_tooth': '27'},
{'box_2d': [701, 505, 739, 553], 'tooth_id': 'unknown', 'label': 'caries', 'score': 0.67, 'near_tooth': '14'},
{'box_2d': [702, 637, 724, 660], 'tooth_id': 'unknown', 'label': 'caries', 'score': 0.3, 'near_tooth': '45'}
]
```

A total of 30 teeth were visualized, with all primary dentition units accounted for. Wisdom teeth status:

- **#18 (left maxillary third molar)**: Fully erupted, non-impacted.
- **#48 (left mandibular third molar)**: Suspicious for impaction due to low confidence in localization (FDI #48).

- **#22 (left maxillary lateral incisor)**: Areas of concern noted for calculus deposition.
- **Near #37 (right mandibular first molar)**: Shows evidence of impacted tooth.
- **Near #27 (left mandibular second molar)**: Suspicious for residual root fragment (root stump).
- **Near #14 (right maxillary canine)**: Suspicious for early carious lesion.
- **Near #45 (left mandibular first molar)**: Areas of concern for carious involvement.

- **Near #37 (right mandibular first molar)**: Presence of dental restoration.
-

1. Suspicious carious lesions near #14 and #45 require immediate evaluation for potential restorative intervention.
2. Impacted tooth near #37 and suspicious impaction of #48 warrant surgical assessment.
3. Residual root fragment near #27 poses a risk for infection or cystic development.

- Reinforce oral hygiene protocols to mitigate calculus progression on #22.
- Patient education on dietary modifications and fluoride application for caries-prone areas (#14, #45).
- Monitor radiographic changes in the region of #48 during follow-up imaging.

- **6-month recall** for clinical and radiographic reassessment of carious and impacted sites.
- **Referral to oral surgeon** for definitive management of impacted #48 and root fragment near #27.
- **Consultation with restorative/endodontic specialist** for carious lesions near #14 and #45 to determine treatment urgency.
