Medical Report

Oral Panoramic X-ray Examination Report

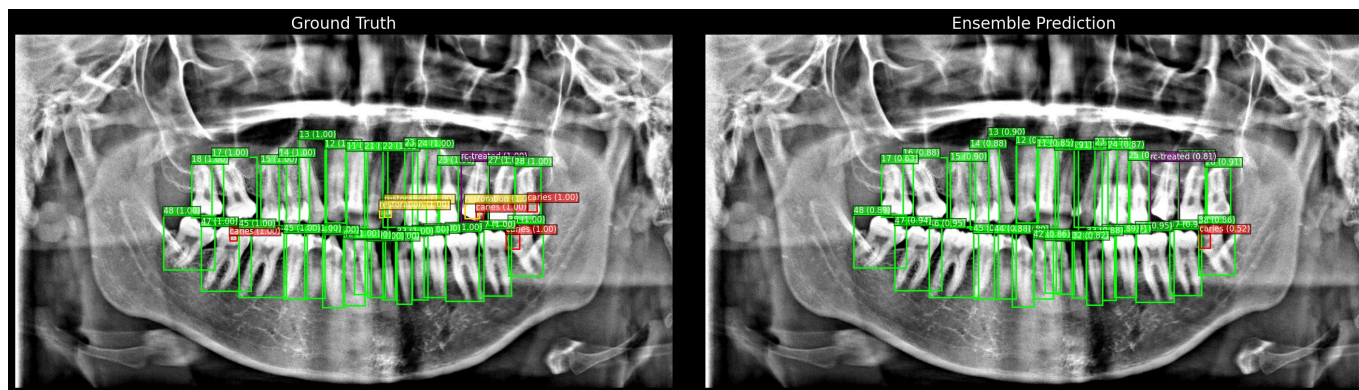
A total of 30 teeth were visualized. The detected wisdom teeth include #28 (upper left third molar), #38 (lower left third molar), and #48 (lower right third molar), all of which are present and not impacted. The upper right third molar (#18) is not visualized in the field of view.

A suspicious area near tooth #38 suggests potential caries. No other pathological lesions or abnormalities were identified.

Evidence of root canal treatment was noted near tooth #25. No other prior restorative or endodontic interventions were observed.

- **Suspicious caries near tooth #38:** Requires further clinical evaluation to confirm presence and extent.
- **Root canal-treated area near tooth #25:** Monitor for signs of apical pathology or secondary caries.

- Reinforce oral hygiene protocols, particularly around tooth #38, to mitigate caries risk.
- Educate on the importance of regular fluoride application and dietary modifications to prevent progression of carious lesions.

- **6-month recall** for radiographic and clinical reassessment of suspicious caries near #38.
 - **Referral to endodontist** for evaluation of root canal-treated area near #25 to confirm treatment efficacy.
 - **Immediate review** if symptoms (e.g., pain, swelling) develop in the posterior mandibular region.
-
