Grounding Caption

Medical Report

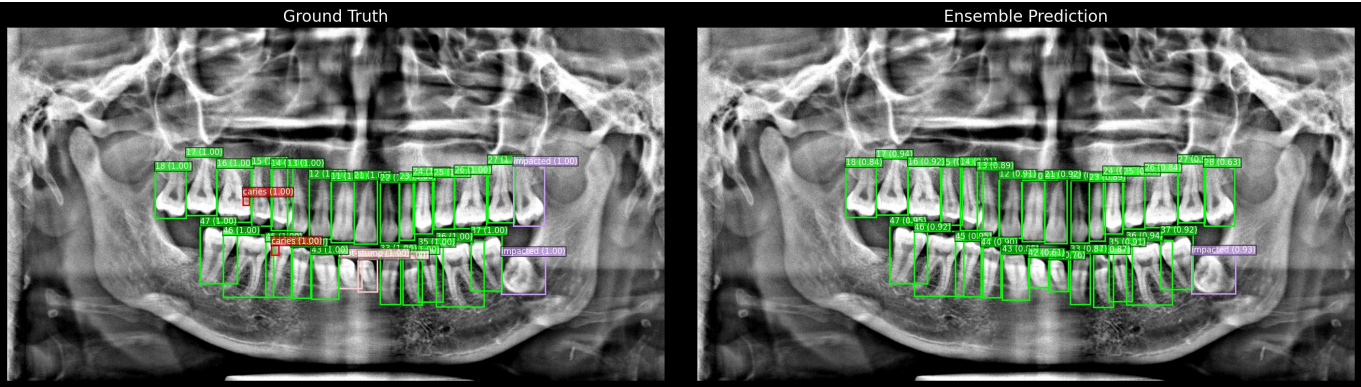
A total of 28 teeth are visualized within the panoramic field. All wisdom teeth are present, with the upper right third molar (#18) fully erupted and non-impacted. The lower right third molar (#28) is also present but exhibits reduced visibility due to lower detection confidence.

A clear indication of **impacted tooth** is observed near tooth #37 (lower left first molar), localized in the posterior mandibular region. This finding is consistent with radiographic signs of bony obstruction or incomplete eruption.

No prior restorations, root canal treatments, implants, or crowns are identified in the examined field.

- Impacted tooth near #37:** Requires evaluation for potential surgical extraction or orthodontic intervention.
- Reduced visibility of #28:** Monitor for progressive impaction or resorption risks.

- Reinforce oral hygiene protocols to mitigate caries and periodontal risks in the posterior mandibular region.
- Schedule regular follow-ups to assess the developmental trajectory of #28.

- Referral to oral surgeon:** For assessment of impacted tooth near #37 and #28.
 - 6-month recall:** To evaluate stability of #28 and monitor for pathological changes.
 - Radiographic re-evaluation in 12 months:** To track eruptive progress of #28 and ensure no compromise to adjacent structures.
-
