Grounding Caption

This localization caption provides multi-dimensional spatial analysis of anatomical structures and pathological findings for this panoramic dental X-ray image, including:

Medical Report

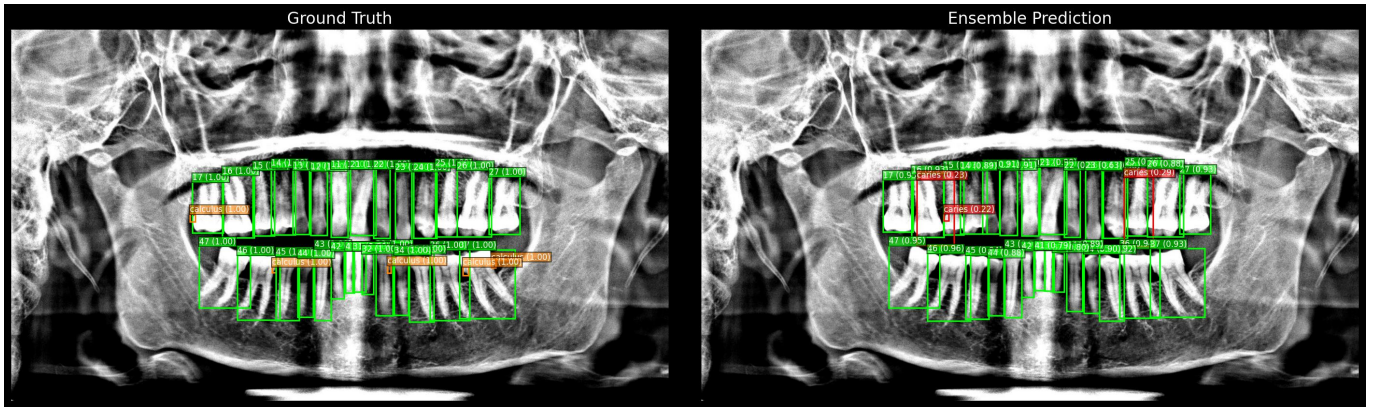
Teeth visibility with center points (total: 28):

Dental Pathological Findings (total: 3):

```
[
  {'box_2d': [565, 392, 662, 564], 'tooth_id': '16', 'label': 'caries', 'score': 0.23},
  {'box_2d': [1108, 385, 1184, 567], 'tooth_id': '25', 'label': 'caries', 'score': 0.29},
  {'box_2d': [636, 481, 649, 500], 'tooth_id': 'unknown', 'label': 'caries', 'score': 0.22, 'near_tooth': '15'}
]
```

A total of 28 teeth are clearly visualized using the FDI numbering system. No wisdom teeth are detected. All visible teeth exhibit normal spatial orientation and anatomical alignment, with no evidence of congenital absence or gross structural abnormalities.

- **#16 (Tooth 16):** Suspicious for carious lesion in the distal region, based on limited radiographic opacity.
- **#25 (Tooth 25):** Areas of concern noted for potential carious involvement on the mesial surface.
- **Near #15 (Tooth 15):** Radiographic feature suspicious for caries adjacent to the distal surface, though localization is indistinct.

- **Suspicious carious involvement** in #16 (distal), #25 (mesial), and near #15 warrants immediate clinical correlation to confirm diagnosis and prevent progression.
- **Absence of wisdom teeth** noted, consistent with panoramic imaging limitations.

- Reinforce **oral hygiene protocols** to mitigate caries risk in #15, #16, and #25.
- Emphasize **dietary counseling** to reduce cariogenic exposure in high-risk areas.

- Schedule **6-month recall** for radiographic reassessment of suspicious caries.
- Refer to **restorative specialist** for definitive diagnosis and treatment planning for #15, #16, and #25.
- Consider **bitewing radiographs** for supplemental evaluation of interproximal caries in affected regions.
