Grounding Caption

Oral Panoramic Radiographic Examination Report

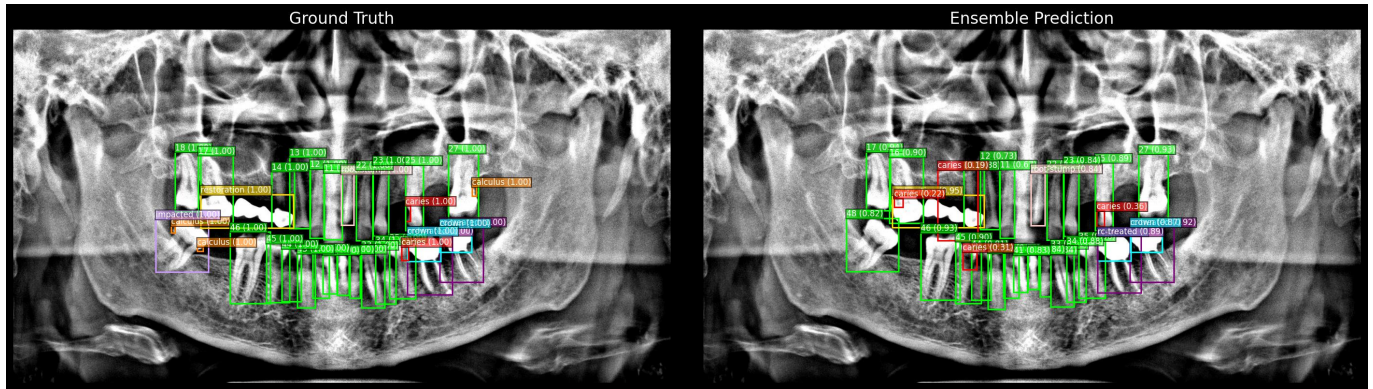
A total of 21 teeth are visualized, with the following distribution:

- Maxillary arch: 11 teeth (#11, #12, #13, #16, #17, #22, #23, #25, #27).
- Mandibular arch: 10 teeth (#31, #32, #33, #34, #35, #41, #42, #43, #44, #45, #46, #48).

Wisdom teeth: Only the right mandibular wisdom tooth (#48) is present and fully erupted, with no evidence of impaction.

1. **Sign of a root stump** noted near tooth #22.
2. **Suspicious areas of caries** identified near:
 - Tooth #25 (low confidence).
 - Tooth #45 (low confidence).
 - Tooth #16 (very low confidence).
 - Tooth #13 (very low confidence).

1. **Presence of a restoration** adjacent to tooth #13.
 2. **Root canal-treated tooth** with a **crown** on tooth #35.
 3. **Crown placement** observed near tooth #27.
-

- **Root stump near #22:** Requires clinical correlation to determine if residual apical tissue remains.
- **Suspected early caries:** Near #25, #45, #16, and #13. Prioritize radiographic and tactile examination to confirm.

- Reinforce oral hygiene protocols, emphasizing interproximal cleaning near #25 and #45.
- Monitor suspicious cariogenic areas with follow-up imaging and recall.

- **6-month recall** for reassessment of carious lesions and root stump.
 - **Referral to endodontist** for evaluation of #35's root canal treatment success.
 - **Dental caries management** for #25 and #45: Consider preventive resin restorations or sealants if non-cavitated.
-
