Grounding Caption

This localization caption provides multi-dimensional spatial analysis of anatomical structures and pathological findings for this panoramic dental X-ray image, including:

Medical Report

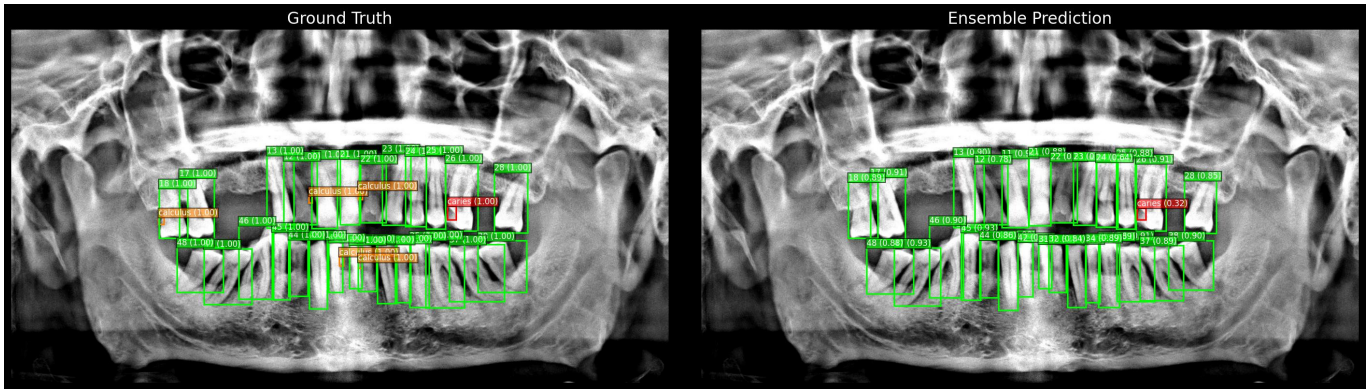
A total of 27 teeth are visualized in the panoramic image. All four wisdom teeth (#18, #28, #38, #48) are present and non-impacted. The dental arch exhibits no evidence of significant resorption or bony expansion.

An area of concern is noted near tooth #26, suspicious for early carious lesion. No other pathological changes, including periapical radiolucency, impacted teeth, or calculus, are observed.

No prior restorations, crowns, root canal treatments, or implants are identified.

- **Area of suspected caries near #26:** Requires clinical correlation and further diagnostic evaluation to confirm and address.

- Reinforce patient education on interproximal plaque control, particularly in the region of #26.
- Emphasize regular fluoride application and dietary counseling to mitigate caries risk.

- **6-month recall** for radiographic monitoring of the suspicious area near #26.
- **Referral to general dentist or pediatric dentist** for direct clinical assessment of the suspected caries.
- Schedule follow-up imaging if there is no improvement in oral hygiene compliance or risk factors persist.
