Grounding Caption

Medical Report

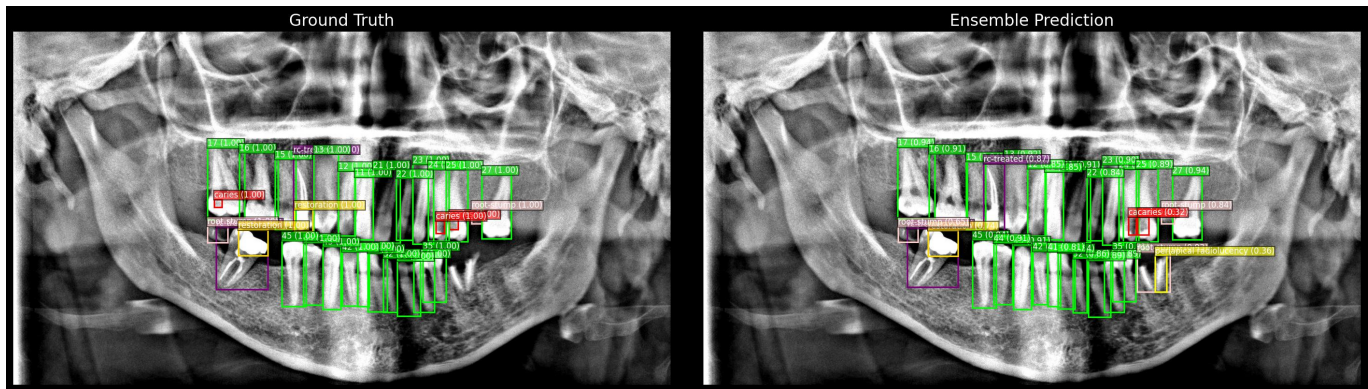
A total of 22 teeth are visualized. No wisdom teeth (third molars) are present bilaterally. The overall dental arch appears intact with no evidence of supernumerary teeth.

- **Sign of root stumps** near tooth **#35** and **#27** (definitive).
- **Suspected root stumps** near tooth **#17** (confidence < 0.80).
- **Areas of concern noted for caries** near tooth **#24** and **#25** (low confidence).
- **Suspected periapical radiolucency** near tooth **#35** (low confidence).

- **Root canal-treated (rc-treated)** teeth confirmed near **#45** and **#15**.
 - **Restoration** present near **#45** (likely composite or amalgam).
-

- **Root stumps near #35 and #27** suggest prior extractions or failed endodontic treatments; clinical correlation required.
- **Caries near #24 and #25** require further evaluation for potential restoration or preventive intervention.

- Reinforce oral hygiene protocols to mitigate progression of suspicious carious lesions.
- Monitor areas of concern near #24, #25, and #17 during routine follow-ups.

- **6-month recall** to reassess periapical status of #35 and progression of caries.
- **Referral to endodontist** for treatment planning of root stumps near #35 and #27.
- **Radiographic review** of #45 restoration for integrity and secondary caries.
