# Medical Report

## Oral Panoramic X-ray Examination Report

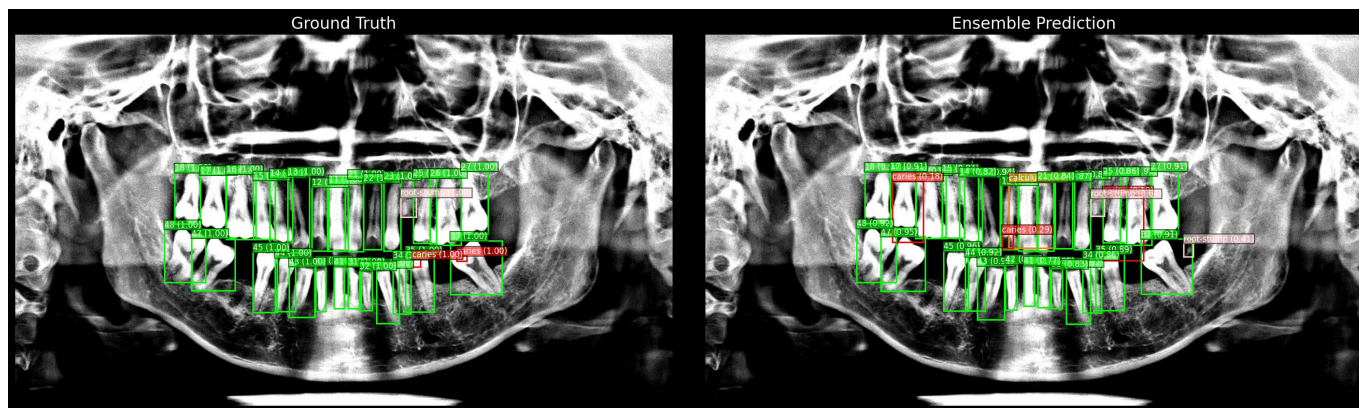
A total of 27 teeth are visualized within the field of view, including the presence of both upper right (tooth #18) and upper left (tooth #48) wisdom teeth, which are fully erupted and not impacted. No evidence of prior tooth extraction is observed.

- Suspicious for caries on #26 (upper right first molar) and #17 (lower right second premolar).
- Areas of concern noted for potential caries near tooth #12 (lower left second premolar).

- Suspected calculus deposits on #11 (lower left first premolar).

- Suspicious for root stumps near tooth #23 (upper right first molar) and #37 (upper left third molar).

No prior restorations, root canal treatments, or implants are observed.

1. **Deep caries suspicion on #26 and #17:** Requires evaluation for restorative intervention.
2. **Root stumps near #23 and #37:** Further radiographic assessment recommended to confirm presence of residual roots.
3. **Calculus deposits on #11:** Reinforcement of professional scaling or home plaque control.

- Reinforce patient education on plaque removal techniques, particularly for #11.
- Monitor suspicious areas of potential caries on #12 and #17 during routine recall visits.

- Schedule a 6-month recall for monitoring of carious lesions and calculus management.
  - Referral to endodontist for definitive diagnosis and treatment planning of suspected root stumps (#23, #37).
  - Consider bitewing radiographs for confirmation of carious involvement on #26 and #17.
-
