Grounding Caption

This localization caption provides multi-dimensional spatial analysis of anatomical structures and pathological findings for this panoramic dental X-ray image, including:

Medical Report

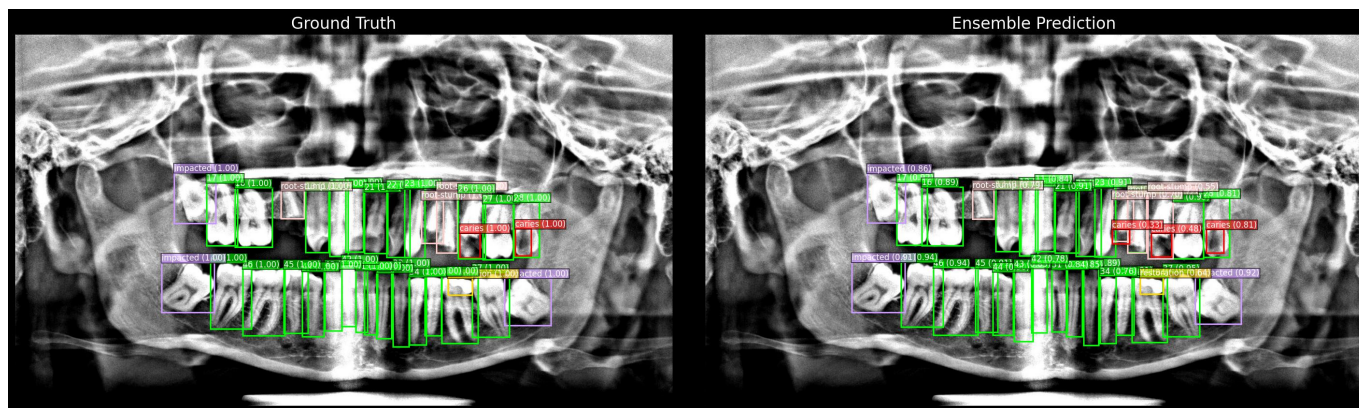
Teeth visibility with center points (total: 24):

Wisdom teeth detection (total: 1):

```
[
{'box_2d': [1307, 427, 1374, 582], 'tooth_id': '28', 'is_impacted': false, 'score': 0.81}
]
```

Dental Pathological Findings (total: 10):

```
[
{'box_2d': [1107, 418, 1157, 571], 'tooth_id': '25', 'label': 'root-stump', 'score': 0.69},
{'box_2d': [1285, 635, 1405, 758], 'tooth_id': 'unknown', 'label': 'impacted', 'score': 0.92, 'near_tooth': '37'},
{'box_2d': [383, 594, 523, 727], 'tooth_id': 'unknown', 'label': 'impacted', 'score': 0.91, 'near_tooth': '47'},
{'box_2d': [424, 362, 525, 492], 'tooth_id': 'unknown', 'label': 'impacted', 'score': 0.86, 'near_tooth': '17'},
{'box_2d': [1314, 509, 1360, 571], 'tooth_id': 'unknown', 'label': 'caries', 'score': 0.81, 'near_tooth': '28'},
{'box_2d': [700, 405, 756, 482], 'tooth_id': 'unknown', 'label': 'root-stump', 'score': 0.79, 'near_tooth': '13'},
{'box_2d': [1066, 430, 1122, 540], 'tooth_id': 'unknown', 'label': 'root-stump', 'score': 0.7, 'near_tooth': '25'},
{'box_2d': [1160, 409, 1227, 586], 'tooth_id': 'unknown', 'label': 'root-stump', 'score': 0.55, 'near_tooth': '25'},
{'box_2d': [1169, 519, 1223, 581], 'tooth_id': 'unknown', 'label': 'caries', 'score': 0.48, 'near_tooth': '27'},

{'box_2d': [1067, 509, 1113, 547], 'tooth_id': 'unknown', 'label': 'caries', 'score': 0.33, 'near_tooth': '25'}
]
```

Historical Treatments (total: 1):

```
[
{'box_2d': [1140, 635, 1201, 679], 'tooth_id': 'unknown', 'label': 'restoration', 'score': 0.64, 'near_tooth': '36'}
]
```

The panoramic radiograph visualizes **24 teeth**, with all mandibular and maxillary posterior teeth present. Wisdom teeth analysis reveals **#28** (#48 in FDI notation) is **fully erupted and unimpacted**. No evidence of supernumerary or missing teeth is observed.

- **#25**: Root stump noted with residual apical radiolucency.
- **Near #37**: Impacted tooth identified lateral to the root of #37.
- **Near #47**: Impacted tooth detected mesial to #47.
- **Near #17**: Impacted tooth observed distal to #17.
- **Near #28**: Clear indication of carious lesion adjacent to #28.
- **Near #13**: Root fragment detected with minimal periradicular lucency.
- **Near #25**: Additional root fragment identified with questionable apical lucency.
- **Near #27**: Suspicious for early carious involvement.
- **Near #25**: Areas of concern for possible secondary caries.

- **Near #36**: Presence of a radiopaque restoration material consistent with prior filling.
-

- **Impacted teeth** near **#37** and **#47** require orthodontic/surgical evaluation to assess eruption potential and risk of adjacent tooth resorption.
- **#25 root stump** with associated radiolucency necessitates endodontic assessment for apical pathology.
- **Caries near #28** warrants immediate preventive intervention to prevent progression.

- Reinforce oral hygiene protocols, particularly around impacted teeth (**#37**, **#47**) to mitigate periodontal risk.
- Monitor suspicious carious lesions near **#27** and **#25** with 3-month recall imaging.
- Address root fragments near **#13** and **#25** for potential removal to prevent foreign body reaction.

- **6-month recall** for impacted teeth (near **#37**, **#47**) and carious lesions (**#28**).
- **Referral to endodontist** for evaluation of **#25** apical pathology.
- **Orthodontic consultation** for impacted wisdom teeth to determine surgical exposure or removal.
