Grounding Caption

Medical Report

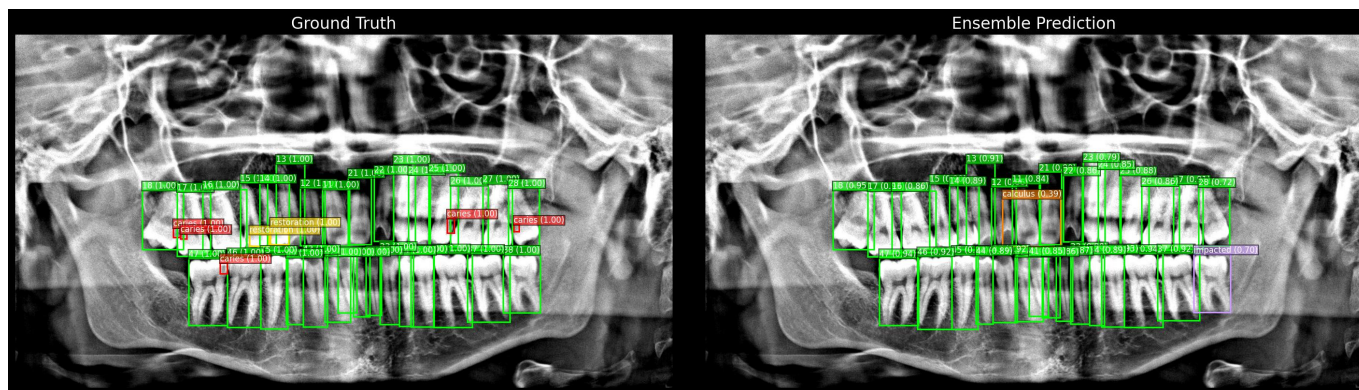
A total of 30 teeth are visualized within the panoramic field. Wisdom teeth (#18 and #28) are present and not impacted.

- **Tooth #11:** Suspicious for calculus deposition on the mesial and distal surfaces.
- **Near tooth #37:** Suspected impacted area in the posterior region, with radiographic features raising concern for possible impaction or bony obstruction.

No prior restorations, root canal treatments, crowns, or implants observed in the examined field.

- Suspected calculus on **tooth #11** requires professional cleaning to mitigate periodontal risk.
- Radiographic irregularity **near tooth #37** suggests possible impaction or bony obstruction; further diagnostic imaging (e.g., CBCT) is recommended for definitive evaluation.

- Reinforce oral hygiene protocols, emphasizing interdental cleaning for **tooth #11** and adjacent areas.
- Monitor suspected calculus and bony changes **near #37** during follow-up visits.

- Schedule a **6-month recall** to reassess calculus resolution post-cleaning and evaluate the suspicious area near **#37**.
- Referral to a periodontist or oral surgeon for **#37** if bony impaction is confirmed.
- Annual panoramic imaging recommended to track any changes in the posterior region.
