## Grounding Caption

# Medical Report

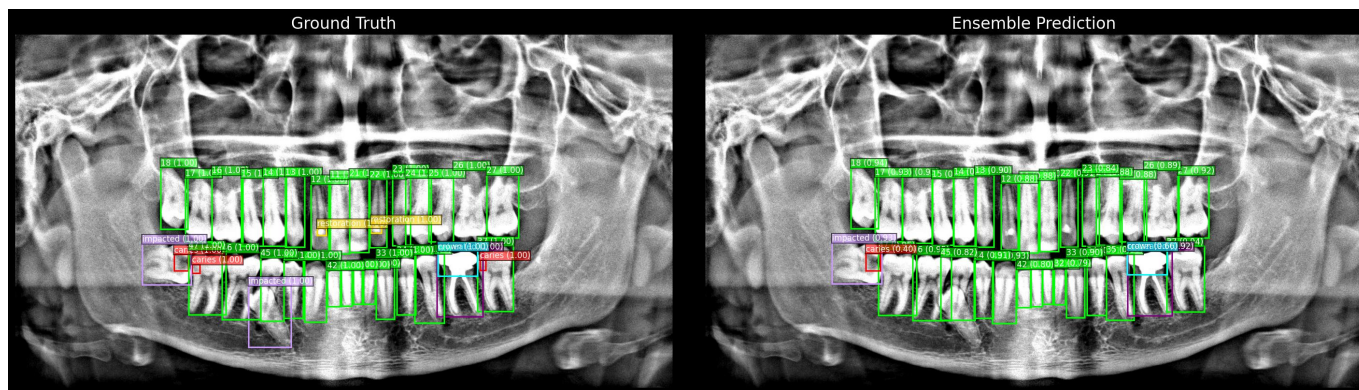
A total of 28 teeth are visualized within the panoramic field, with all teeth anatomically positioned and fully erupted. Wisdom teeth are present and unimpacted, including a fully erupted right mandibular third molar (tooth #18).

- A clear indication of an impacted tooth is noted near tooth #47, with radiographic evidence consistent with partial bony obstruction.
- Areas of concern for carious lesions are observed near tooth #47, with radiolucent changes suggesting early demineralization requiring further clinical correlation.

- A root canal-treated tooth is present on tooth #35, with no evidence of post-treatment complications.
- A definitive crown restoration is visible on tooth #35, indicating prior restorative intervention.

- Immediate attention is required for the impacted tooth near #47, as it may necessitate surgical evaluation.
- The suspicious caries near #47 should be assessed clinically for cavity preparation or preventive measures.

- Reinforce oral hygiene protocols to mitigate caries progression on #47.
- Monitor tooth #35 crown for signs of secondary caries or marginal breakdown.

- Schedule a 6-month recall to reassess the impacted tooth near #47 and caries near #47.
- Referral to an oral surgeon is recommended for definitive management of the impacted tooth near #47.
- Maintain regular 6-month prophylaxis appointments to ensure overall periodontal and caries control.
