Grounding Caption

Medical Report

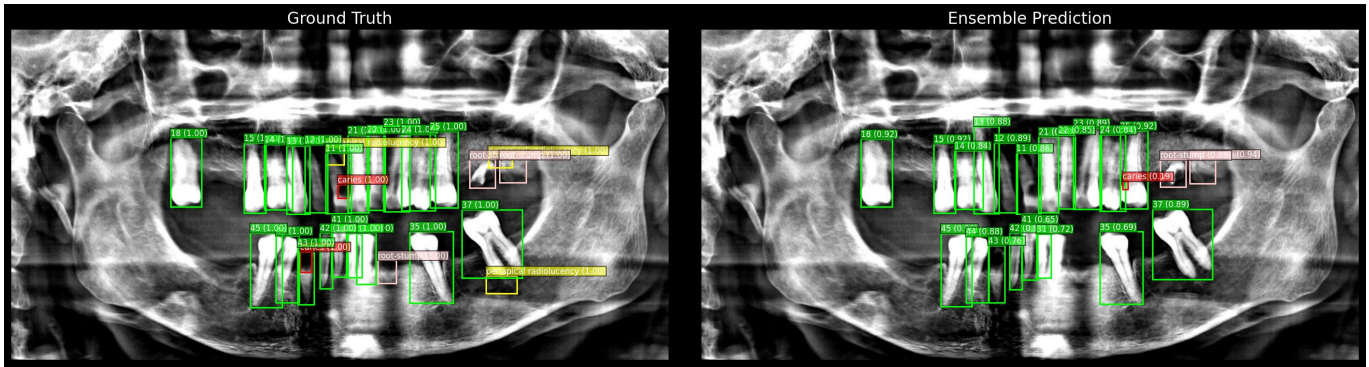
This localization caption provides multi-dimensional spatial analysis of anatomical structures and pathological findings for this panoramic dental X-ray image, including:

- A total of 19 teeth are visualized in the panoramic image.
- Wisdom teeth (third molars) are partially represented: tooth #18 (left mandibular third molar) is present and unimpacted. No other wisdom teeth are detected.

- Clear indication of root stumps near tooth #25 (right maxillary second molar), consistent with prior extraction or resorption.
- Additional root stumps adjacent to tooth #25 are observed, suggesting residual bony spicules or incomplete removal.
- Suspicious for early enamel caries near tooth #24 (right maxillary first molar); further diagnostic evaluation is warranted due to low confidence in this finding.

- No evidence of prior dental treatments (restorations, crowns, root canal therapy, or implants) is identified in the imaging.
-

- Root stumps near tooth #25 require clinical evaluation to assess their impact on adjacent structures or potential for infection.
- Suspected caries near tooth #24 necessitates confirmation via additional imaging or clinical examination to prevent progression.

- Reinforce oral hygiene protocols, emphasizing interproximal cleaning for the right maxillary molars (#24 and #25).
- Monitor for signs of periodontal inflammation or calculus accumulation in the posterior regions.

- Refer to a specialist (e.g., oral surgeon or periodontist) for management of root stumps near #25.
- Schedule a 6-month recall for reassessment of caries suspicion near #24 and to evaluate overall periodontal health.
- Provide patient education on caries prevention, including dietary modifications and fluoride application.
