Grounding Caption

Medical Report

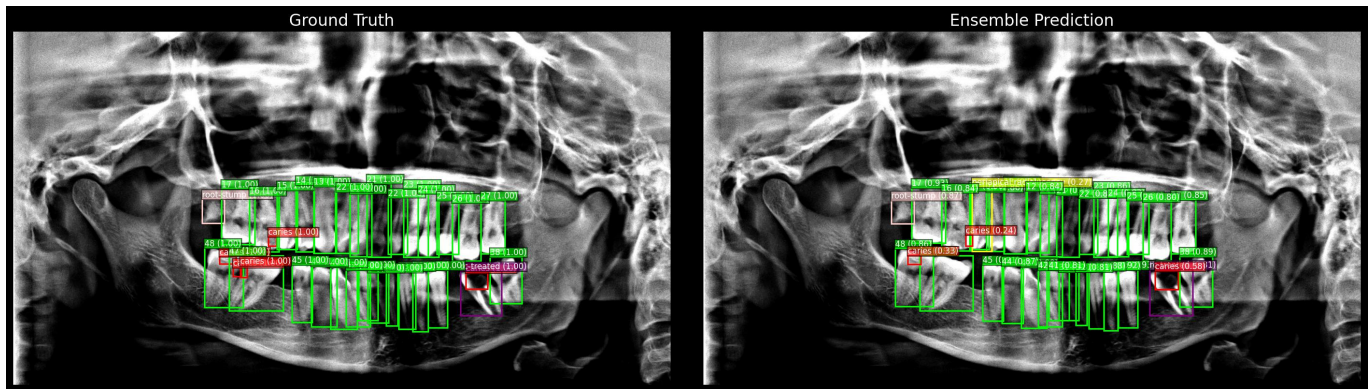
A total of 27 teeth were visualized. All four wisdom teeth (#38, #48, #28, #18) were present; however, only #38 and #48 were explicitly detected. Both #38 and #48 showed non-impacted eruption.

- Suspicious for periapical radiolucency at #15 (maxillary left first molar).
- Presence of a root-stump near tooth #17 (maxillary right first molar).
- Suggestive areas of caries near #38 (mandibular right third molar) and #48 (mandibular left third molar).
- Additional areas of concern noted for suspected caries near #15 (maxillary left first molar).

- Evidence of root canal treatment near #38 (mandibular right third molar).
-

- Periapical radiolucency at #15 suggests apical periodontitis requiring further evaluation.
- Root-stump near #17 may indicate residual apical fragment or non-vital tissue.
- Caries near #38 and #48 necessitate assessment for early intervention.

- Reinforce oral hygiene protocols, particularly for interproximal areas near molars.
- Monitor suspicious carious lesions near #38, #48, and #15 with 3-month recalls.
- Consider fluoride applications to strengthen enamel in high-risk zones.

- Refer #15 to an endodontist for apical pathology evaluation.
- Evaluate root-stump near #17 for possible surgical removal or observation.
- Schedule a 6-month recall to assess caries progression near #38 and #48.
- Confirm functional status of root canal-treated tissue near #38 via clinical examination.
