Grounding Caption

This localization caption provides multi-dimensional spatial analysis of anatomical structures and pathological findings for this panoramic dental X-ray image, including:

Medical Report

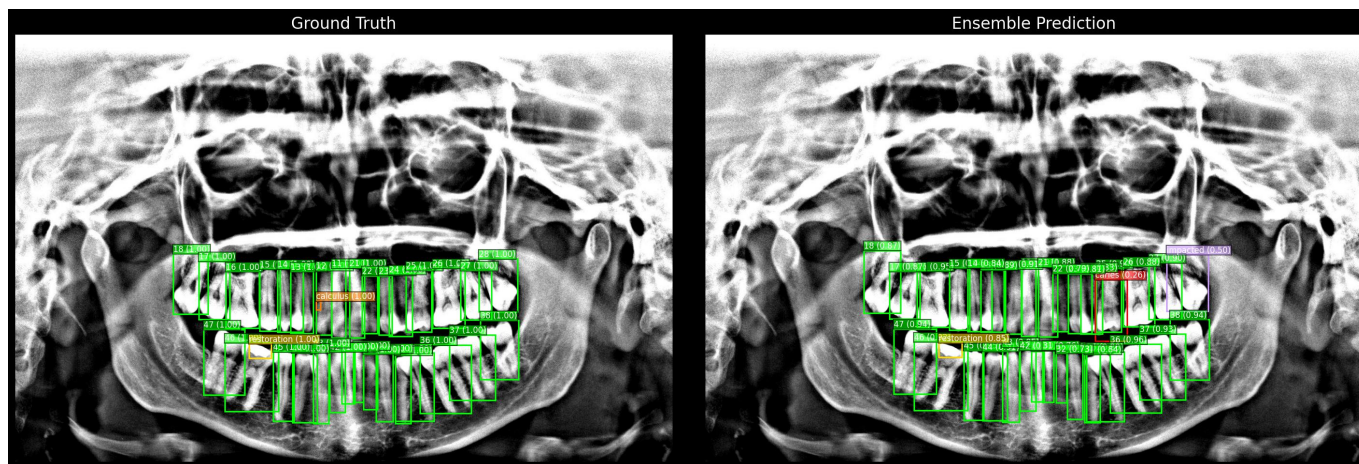
A total of 30 teeth were visualized under the FDI numbering system, with all four wisdom teeth (#18, #28, #38, #48) present and fully erupted. The panoramic radiograph demonstrates adequate clarity for diagnostic evaluation.

- Tooth #25 (Left Mandibular First Molar):** Suspicious for carious lesion in the occlusal or proximal region based on radiographic opacity.
- Near Tooth #27 (Left Mandibular Third Molar):** Suspicious for impacted tooth or radiographic artifact adjacent to the fully erupted #27, requiring further clarification.

- Near Tooth #46 (Left Maxillary First Molar):** Presence of a restoration (filling) in proximity to #46, consistent with prior caries management.
-

- Deep caries suspicious on #25:** Requires immediate clinical correlation and potential restorative intervention.
- Impacted/suspected pathology near #27:** Further imaging (e.g., CBCT) or clinical examination to confirm etiology and assess for resorption or infection.

- Reinforce oral hygiene protocols for caries-prone areas (#25) to mitigate progression.
- Monitor radiographic changes in the #27 region during routine recalls.

- Schedule a 6-month recall for re-evaluation of #25 and the #27 region.
- Refer for specialist evaluation (e.g., oral surgeon) if the #27 lesion persists or worsens.
- Evaluate the restoration near #46 for integrity and secondary caries during the next clinical visit.
