# Medical Report

## Oral Panoramic Radiographic Examination Report

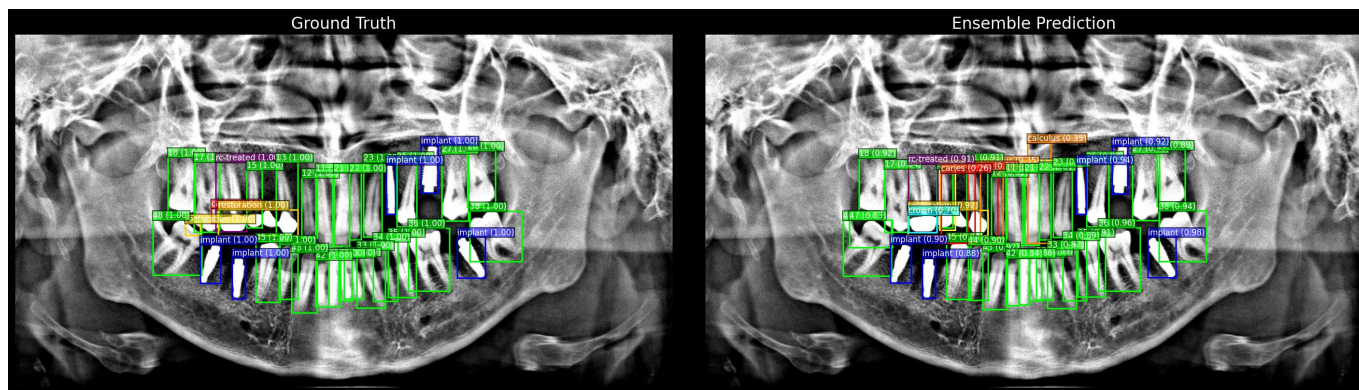
The panoramic radiograph visualizes **26 teeth** in the FDI numbering system. All four wisdom teeth (#18, #28, #38, #48) are present and **not impacted**. The dentition shows a mix of natural teeth and dental implants.

- #13 (right central incisor) exhibits suspicious lucency in the enamel-dentin junction, consistent with **suspicious for occlusal caries**.

- **Areas of concern noted for caries** near #15 (left first molar), potentially involving the proximal surface.

- **Suspicious for periapical radiolucency** at the apical region of #15 (left first molar), suggesting possible apical periodontitis.

- **Suspected supragingival calculus** detected on the lingual surfaces of #12 (right lateral incisor) and #21 (left central incisor).

- **Restoration:** Presence of a composite resin restoration on the mesial surface of #15.

- **Root Canal-Treated (RC-Treated):** Radiographic evidence of a root canal-treated #15 with a post space.

- **Crown:** A metal-ceramic crown is apparent on #15.

- Implant near #38 (right third molar), #25 (left first premolar), #27 (left second molar), #48 (left third molar), and #45 (right first molar).

- All implants demonstrate osseointegration and no signs of peri-implant radiolucency.

- Suspicious periapical radiolucency on #15** requiring further evaluation for potential apical pathology.
- Caries involvement on #13 and near #15** necessitating prompt intervention to prevent progression.
- Suspected calculus deposits on #12 and #21** indicating a need for professional scaling and hygiene reinforcement.

- Reinforce oral hygiene practices, emphasizing interdental cleaning (flossing or interdental brushes) for caries-prone areas.
- Educate on biofilm control to minimize calculus accumulation on anterior teeth.
- Advise fluoride supplementation for caries-prone regions (#13 and #15).

- **Urgent:** Referral to endodontist for evaluation of #15's periapical radiolucency.
  - **Dental Hygiene Recall:** Schedule scaling and root planing within 4 weeks, focusing on #12 and #21.
  - **Recall Interval:** 6-month follow-up to monitor caries near #15 and implant health.
-
