Grounding Caption

This localization caption provides multi-dimensional spatial analysis of anatomical structures and pathological findings for this panoramic dental X-ray image, including:

Medical Report

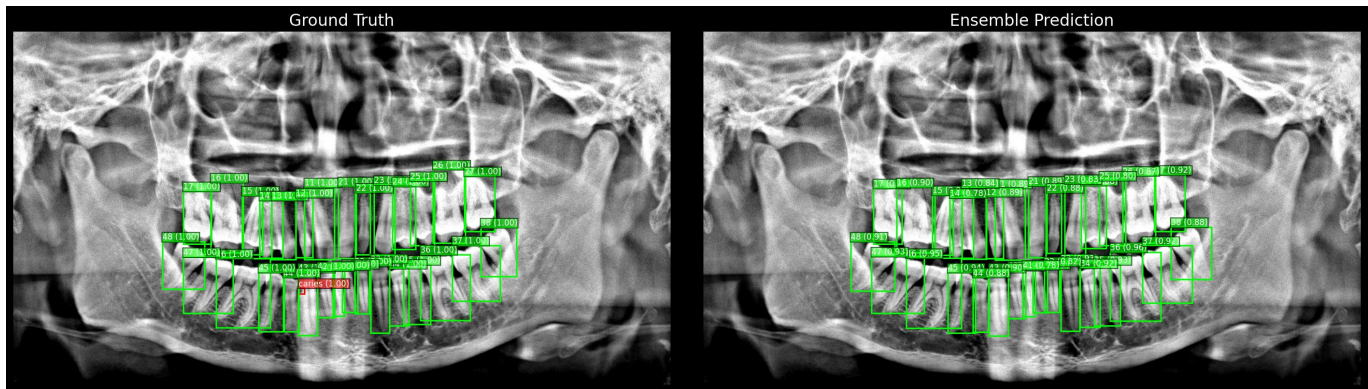
Teeth visibility with center points (total: 30):

Wisdom teeth detection (total: 2):

Dental Pathological Findings (total: 0):

Historical Treatments (total: 0):

A total of 30 teeth are visualized, consistent with a complete dentition excluding the absence of wisdom teeth #18 and #28. Wisdom teeth #38 (right maxillary third molar) and #48 (left mandibular third molar) are present and non-impacted, with no signs of pericoronitis or radiographic abnormalities. The remaining teeth demonstrate normal alignment and eruption.

No pathological findings are identified on the radiographic examination.

No prior dental treatments, restorations, or implants are observed in the field.

- Absence of wisdom teeth #18 and #28 requires clinical correlation to determine if congenitally missing or unerupted.
- No urgent pathological conditions detected.

- Reinforce oral hygiene protocols to prevent periodontal disease, particularly near the wisdom teeth (#38, #48).
- Monitor for asymptomatic unerupted teeth during follow-up visits.

- Schedule a 6-month recall for routine evaluation and radiographic monitoring of #18 and #28 status.
- Consider referral to an oral surgeon for further assessment of missing wisdom teeth if clinically indicated.
- Continue annual panoramic imaging for longitudinal monitoring of dental health.
