Grounding Caption

This localization caption provides multi-dimensional spatial analysis of anatomical structures and pathological findings for this panoramic dental X-ray image, including:

Medical Report

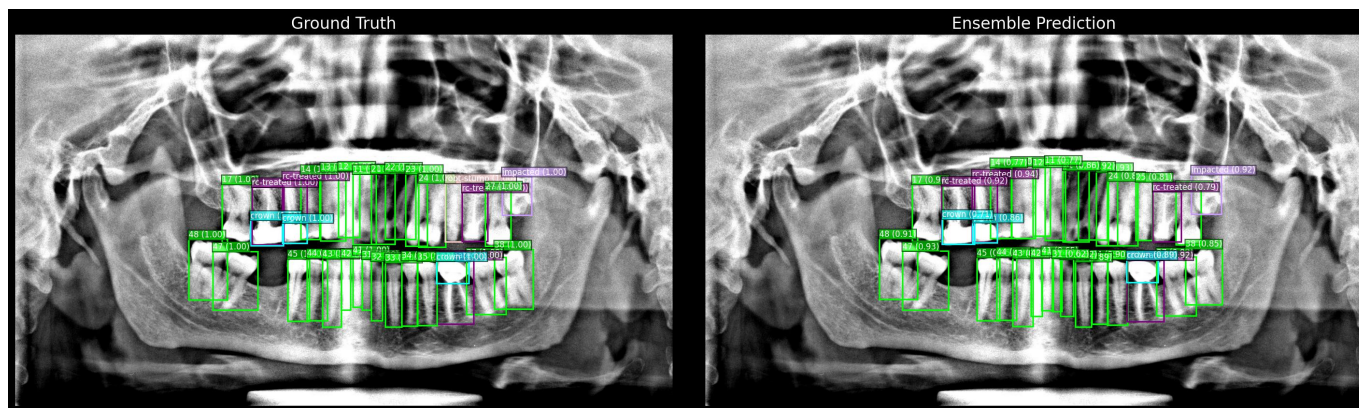
Teeth visibility with center points (total: 25):

Wisdom teeth detection (total: 2):

Dental Pathological Findings (total: 1):

```
[
  {'box_2d': [1275, 365, 1354, 469], 'tooth_id': 'unknown', 'label': 'impacted', 'score': 0.92, 'near_tooth': '27'}
]
```

Historical Treatments (total: 7):

```
[
  {'box_2d': [699, 376, 765, 543], 'tooth_id': 'unknown', 'label': 'rc-treated', 'score': 0.94, 'near_tooth': '14'},
  {'box_2d': [1106, 590, 1202, 751], 'tooth_id': 'unknown', 'label': 'rc-treated', 'score': 0.92, 'near_tooth': '35'},
  {'box_2d': [619, 395, 706, 548], 'tooth_id': 'unknown', 'label': 'rc-treated', 'score': 0.92, 'near_tooth': '17'},
  {'box_2d': [1105, 589, 1187, 649], 'tooth_id': 'unknown', 'label': 'crown', 'score': 0.89, 'near_tooth': '35'},
  {'box_2d': [701, 491, 765, 544], 'tooth_id': 'unknown', 'label': 'crown', 'score': 0.86, 'near_tooth': '14'},
  {'box_2d': [1173, 410, 1247, 542], 'tooth_id': 'unknown', 'label': 'rc-treated', 'score': 0.79, 'near_tooth': '27'},
  {'box_2d': [621, 482, 706, 548], 'tooth_id': 'unknown', 'label': 'crown', 'score': 0.71, 'near_tooth': '17'}
]
```

A total of 25 teeth are visualized. Wisdom teeth at #48 and #38 are fully erupted and not impacted.

Clear indication of an impacted tooth near #27.

- Root canal-treated tooth near #14 and #17.
 - Presence of crowns on teeth near #14, #17, and #35.
 - Root canal-treated tooth near #27.
-

- Impacted tooth near #27 requires evaluation for potential surgical removal.
- Existing root canal-treated teeth near #14, #17, and #27 necessitate monitoring for secondary caries or apical pathologies.

- Reinforce oral hygiene protocols around impacted #27 and near-treated areas (#14, #17, #27, #35).
- Emphasize regular interdental cleaning to mitigate periodontal risks around restored teeth.

- **Referral:** Consult an oral surgeon for assessment of impacted #27.
- **Recall:** Schedule 6-month follow-up to monitor restorations and impacted site.
- **Endodontic Review:** Reassess root canal-treated teeth (#14, #17, #27) at the next recall for signs of failure.
