Medical Report

Oral Panoramic Radiographic Examination Report

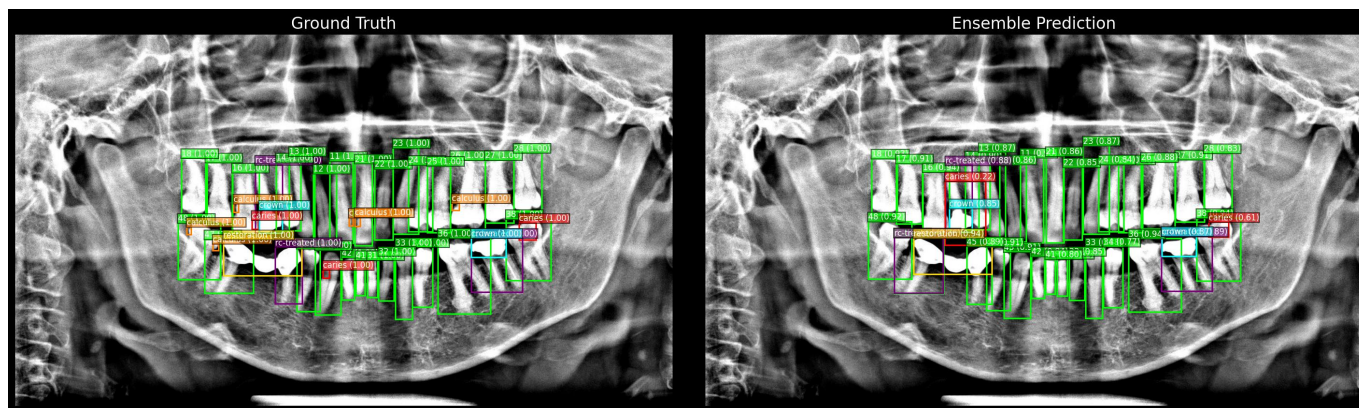
A total of 28 teeth are visualized with clear anatomical localization. All four wisdom teeth (#18, #28, #38, #48) are present and non-impacted, demonstrating normal eruption patterns.

- Areas of concern noted for **suspicious carious lesions**:
- Near tooth #38 (right mandibular third molar), with radiolucent demarcation.
- Near tooth #14 (left maxillary second premolar), exhibiting low-confidence suspicious radiolucency.

- **Restorations**:
- Presence of a restoration near tooth #45 (left mandibular first molar).
- **Root canal-treated teeth**:
- Rc-treated tooth noted near #47 (left mandibular third molar).
- Rc-treated teeth observed near #36 (right mandibular first molar) and #14 (left maxillary second premolar).
- **Crowns**:
- Crowns identified near #36 (right mandibular first molar) and #14 (left maxillary second premolar).

- **Suspicious carious lesions** near #38 and #14 require immediate clinical correlation for definitive diagnosis and intervention.
- **Non-impacted wisdom teeth** (#18, #28, #38, #48) demonstrate normal alignment; no acute complications observed.

- Reinforce oral hygiene protocols, emphasizing interproximal cleaning for high-risk areas (#38, #14).
- Monitor suspicious radiolucent regions for progression during subsequent radiographic evaluations.

- **6-month recall** for radiographic reassessment of carious lesions and restorative integrity.
- Referral to general dentist for clinical evaluation of suspicious caries near #38 and #14.
- Continue regular surveillance of rc-treated teeth (#36, #14, #47) for apical health and restoration longevity.
