Grounding Caption

This localization caption provides multi-dimensional spatial analysis of anatomical structures and pathological findings for this panoramic dental X-ray image, including:

Medical Report

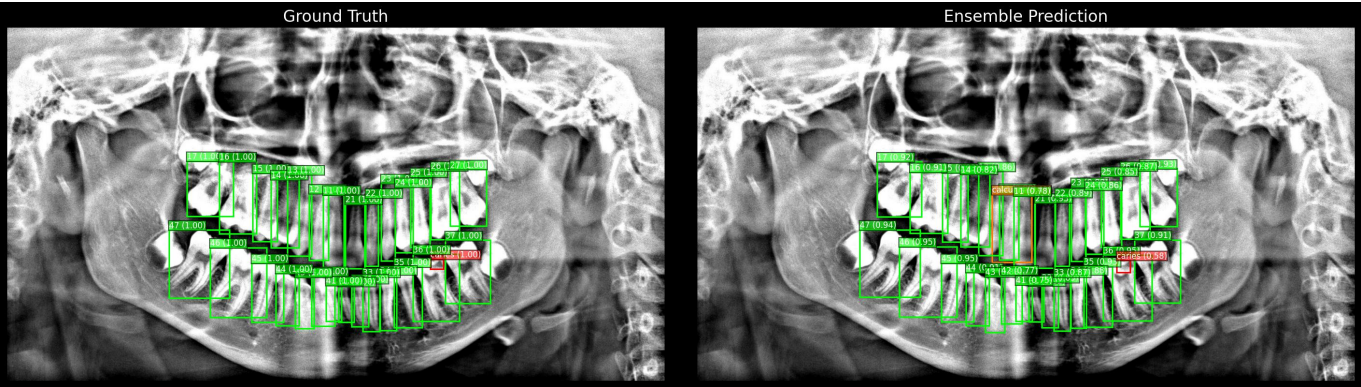
The panoramic radiograph visualizes 28 teeth, with no evidence of wisdom teeth (3rd molars) present bilaterally. The tooth positions align with standard FDI numbering, and no gross anatomical anomalies are noted.

- **Tooth #12 (FDI):** Suspected calculus accumulation on the buccal/lingual surfaces.
- **Near tooth #36 (FDI):** Suspicious carious lesion identified in the interproximal region, requiring further evaluation.

No restorations, root canal treatments, crowns, or implants are detectable in the radiographic field.

- **Suspected calculus on #12** and **suspicious caries near #36** require immediate clinical correlation to confirm diagnosis.
- Absence of wisdom teeth is consistent with prior clinical documentation.

- Reinforce biofilm control techniques for #12 to mitigate calculus progression.
- Advocate for targeted caries prevention strategies for #36, including fluoride applications and dietary counseling.

- Schedule a 6-month recall for radiographic and clinical reassessment of #12 and #36.
- Refer to endodontic specialty for definitive evaluation of the suspicious carious lesion near #36 if clinical symptoms persist.
- Document the absence of wisdom teeth in the patient's long-term treatment plan.
