Grounding Caption

This localization caption provides multi-dimensional spatial analysis of anatomical structures and pathological findings for this panoramic dental X-ray image, including:

Medical Report

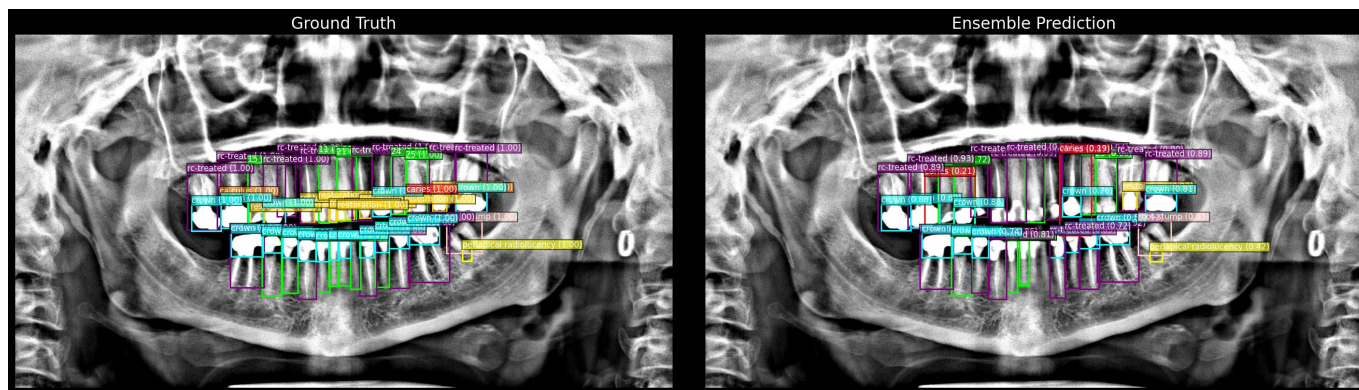
A total of 9 teeth were visualized in the panoramic image, distributed across both arches. No wisdom teeth (third molars) were present in the field. The detected teeth included #14, #15, #21, #24, #25, #31, #41, #42, and #45. Overall dental structure appears stable with multiple prior restorative and endodontic interventions documented.

- **Tooth #14:** Suspicious for caries involving the tooth.
- **Near tooth #25:** Clear indication of a root stump.
- **Near tooth #25:** Suspicious for periapical radiolucency, suggesting possible apical pathology.
- **Near tooth #24:** Suspicious for caries adjacent to the region.

- **Near tooth #24:** Presence of a crown and root canal treatment.
 - **Near tooth #25:** Crown, root canal treatment, and restoration documented.
 - **Near tooth #15:** Root canal treatment and crown placed.
 - **Near tooth #14:** Root canal treatment and crown noted.
 - **Near tooth #31:** Multiple crowns and root canal treatments observed.
 - **Near tooth #45:** Root canal treatment and crown identified.
 - **Near tooth #21:** Root canal treatment documented.
-

- **Deep caries suspicion on #14 and near #24:** Requires immediate evaluation for potential operative intervention.
- **Root stump near #25:** Indicates prior extraction or resorption; assess for infection risk.
- **Periapical radiolucency near #25:** Suggests apical pathology; endodontic re-evaluation is warranted.

- Reinforce oral hygiene education, emphasizing interproximal cleaning for caries-prone regions (e.g., near #24).
- Monitor for calculus accumulation in areas with prior restorative work (e.g., near #25, #31).

- Schedule a 6-month recall for radiographic assessment of suspicious caries and apical pathology.
 - Referral to an endodontist for further evaluation of the periapical radiolucency near #25.
 - Prophylactic review of root canal-treated teeth (#15, #24, #25, #31, #45) to detect secondary caries or apical involvement.
-
