### Oral Panoramic Radiographic Examination Report

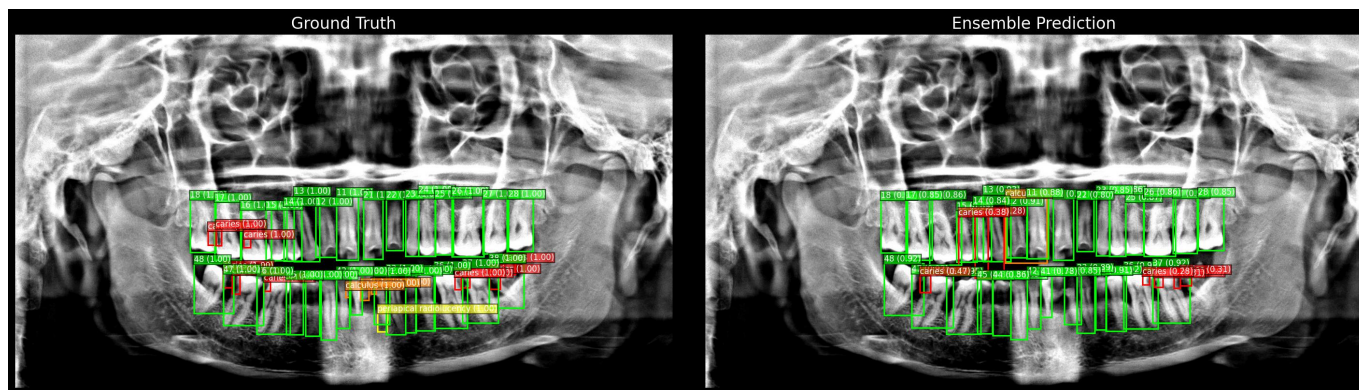
A total of 30 teeth were visualized on the panoramic image. All three wisdom teeth (#18, #28, #48) were present and non-impacted. No evidence of fractures, abscesses, or bone resorption was observed.

- Suspicious for carious lesions on **#13** and **#15**.
- Suggestive of calculus deposits on **#12**.
- Areas of concern noted for potential caries near **#47** and **#37** (multiple small radiolucent regions).
- Additional suspicious caries near **#36** and **#37** in interproximal areas.

No restorations, crowns, root canal treatments, or implants were observed.

- Multiple suspicious carious lesions requiring evaluation: **#13, #15, #36, #37, #47**.
- Suspected calculus on **#12**.

- Reinforce meticulous oral hygiene, particularly for **#12** and interproximal regions.
- Monitor suspicious caries near **#36, #37, #47** for progression.

- Schedule a **6-month recall** for clinical correlation and re-evaluation of suspicious caries.
  - Referral to general dentist for definitive diagnosis and management of **#12 calculus** and **#13/#15 caries**.
  - Consider targeted interproximal caries testing (e.g., laser fluorescence) for areas near **#37**.
-
