## Grounding Caption

This localization caption provides multi-dimensional spatial analysis of anatomical structures and pathological findings for this panoramic dental X-ray image, including:

## Medical Report

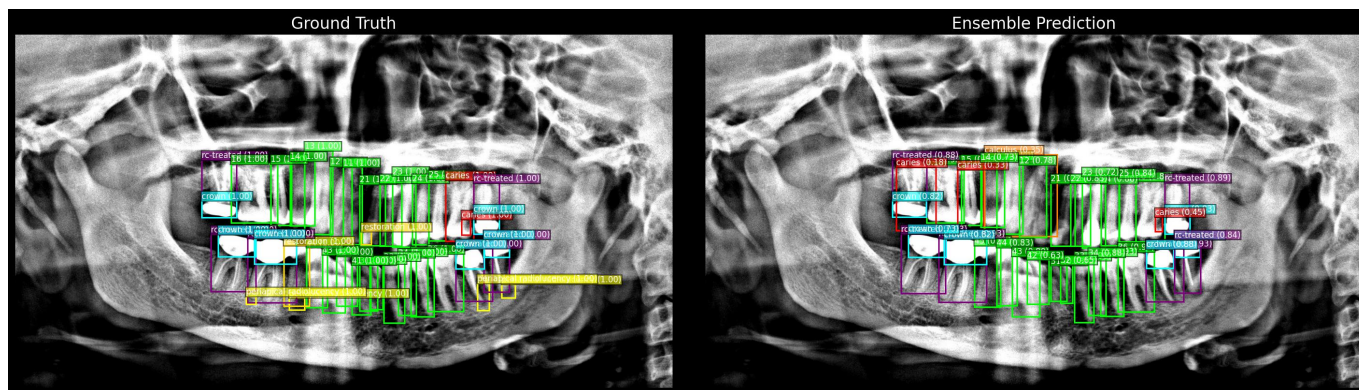
Teeth visibility with center points (total: 21):

Dental Pathological Findings (total: 4):

```
[
{'box_2d': [667, 356, 736, 537], 'tooth_id': '15', 'label': 'caries', 'score': 0.33},
{'box_2d': [738, 316, 930, 532], 'tooth_id': '13', 'label': 'calculus', 'score': 0.35},
{'box_2d': [1189, 481, 1209, 520], 'tooth_id': 'unknown', 'label': 'caries', 'score': 0.45, 'near_tooth': '26'},
{'box_2d': [505, 350, 610, 517], 'tooth_id': 'unknown', 'label': 'caries', 'score': 0.18, 'near_tooth': '16'}
]
```

Historical Treatments (total: 12):

A total of 21 teeth were visualized within the panoramic image, with no visible wisdom teeth (no third molars detected bilaterally). The dentition includes the following teeth under the FDI numbering system: #13, #14, #15, #16, #21, #22, #23, #24, #25, #26, #31, #32, #33, #34, #35, #36, #42, #43, #44, #45. No apparent impactions or gross anatomical abnormalities were observed.

- **#15**: Suggestive of a carious lesion in the occlusal region.
- **#13**: Evidence of calculus deposition on the facial aspect.
- **Near #26**: Suspicious for carious involvement in the mesial aspect.
- **Near #16**: Areas of concern noted for potential caries on the distal surface.

- **Root canal-treated (RC-treated) teeth**:
    - RC-treated tooth with crown restoration on **#16**.
    - RC-treated tooth with crown on **#26**.
    - RC-treated tooth with crown on **#36**.
    - RC-treated tooth on **#45**.
  - **Crown restorations**:
    - Crown on **#16**.
    - Crown on **#26**.
    - Crown on **#36**.
    - Crown on **#45**.
-

- Suspected carious lesions requiring evaluation: **#15**, **near #26**, and **near #16**.
- Calculus accumulation on **#13** necessitating professional scaling.
- No wisdom teeth present; however, monitoring of existing teeth for secondary caries near restorations (e.g., **#26**, **#16**) is advised.

- Reinforce meticulous oral hygiene practices to mitigate calculus formation, particularly in the molar regions.
- Advise fluoride application or sealants for caries-prone areas (e.g., **#15**).
- Educate on dietary modifications to reduce cariogenic exposure.

- **6-month recall** for radiographic re-evaluation of suspicious carious areas and calculus management.
- **Referral to a prosthodontist** for assessment of crown longevity on **#26**, **#36**, and **#45**.
- **Referral to an endodontist** if postoperative symptoms arise from root canal-treated teeth.
- Schedule **scaling and root planing** for **#13** to address calculus deposits.
