Grounding Caption

Medical Report

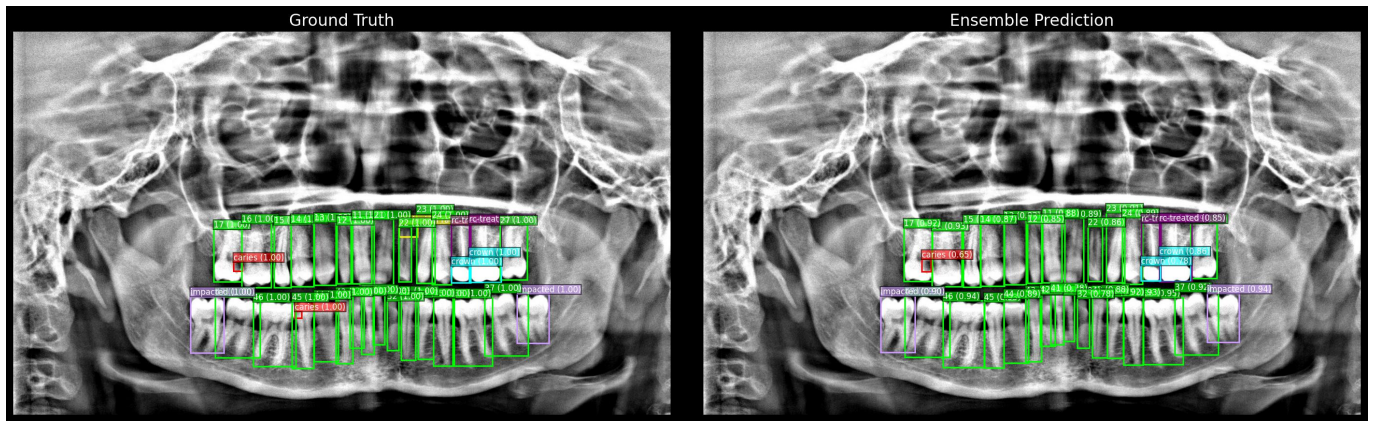
Teeth visibility with center points (total: 26):

```
[
{'point_2d': [1185, 771], 'tooth_id': '36', 'score': 0.95},
{'point_2d': [671, 778], 'tooth_id': '46', 'score': 0.94},
{'point_2d': [748, 780], 'tooth_id': '45', 'score': 0.93},
{'point_2d': [1108, 770], 'tooth_id': '35', 'score': 0.93},
{'point_2d': [628, 584], 'tooth_id': '16', 'score': 0.93},
{'point_2d': [577, 759], 'tooth_id': '47', 'score': 0.93},
{'point_2d': [1062, 761], 'tooth_id': '34', 'score': 0.92},
{'point_2d': [1271, 750], 'tooth_id': '37', 'score': 0.92},
{'point_2d': [553, 574], 'tooth_id': '17', 'score': 0.92},
{'point_2d': [802, 568], 'tooth_id': '13', 'score': 0.92},
{'point_2d': [1062, 556], 'tooth_id': '23', 'score': 0.91},
{'point_2d': [851, 764], 'tooth_id': '43', 'score': 0.91},
{'point_2d': [692, 577], 'tooth_id': '15', 'score': 0.9},
{'point_2d': [1290, 565], 'tooth_id': '27', 'score': 0.9},
{'point_2d': [887, 743], 'tooth_id': '42', 'score': 0.9},
{'point_2d': [955, 564], 'tooth_id': '21', 'score': 0.89},

{'point_2d': [806, 770], 'tooth_id': '44', 'score': 0.89},
{'point_2d': [1105, 565], 'tooth_id': '24', 'score': 0.89},
{'point_2d': [899, 562], 'tooth_id': '11', 'score': 0.88},
{'point_2d': [1021, 758], 'tooth_id': '33', 'score': 0.88},
{'point_2d': [745, 575], 'tooth_id': '14', 'score': 0.87},
{'point_2d': [1010, 572], 'tooth_id': '22', 'score': 0.86},
{'point_2d': [853, 570], 'tooth_id': '12', 'score': 0.85},
{'point_2d': [942, 738], 'tooth_id': '31', 'score': 0.84},
{'point_2d': [912, 739], 'tooth_id': '41', 'score': 0.78},
{'point_2d': [979, 751], 'tooth_id': '32', 'score': 0.78}
]
```

Dental Pathological Findings (total: 3):

```
[
{'box_2d': [1298, 674, 1381, 800], 'tooth_id': 'unknown', 'label': 'impacted', 'score': 0.94, 'near_tooth': '37'},
{'box_2d': [456, 680, 545, 826], 'tooth_id': 'unknown', 'label': 'impacted', 'score': 0.9, 'near_tooth': '47'},
{'box_2d': [563, 586, 618, 618], 'tooth_id': 'unknown', 'label': 'caries', 'score': 0.65, 'near_tooth': '17'}
]
```

Historical Treatments (total: 4):

```
[
{'box_2d': [1129, 492, 1179, 641], 'tooth_id': 'unknown', 'label': 'rc-treated', 'score': 0.89, 'near_tooth': '24'},
{'box_2d': [1175, 576, 1256, 643], 'tooth_id': 'unknown', 'label': 'crown', 'score': 0.86, 'near_tooth': '27'},
{'box_2d': [1175, 491, 1259, 644], 'tooth_id': 'unknown', 'label': 'rc-treated', 'score': 0.85, 'near_tooth': '27'},
{'box_2d': [1128, 602, 1178, 642], 'tooth_id': 'unknown', 'label': 'crown', 'score': 0.78, 'near_tooth': '24'}
]
```

A total of 26 permanent teeth are visualized with no evidence of congenitally missing teeth. All visible teeth exhibit normal morphology and alignment. Wisdom teeth are absent from the field of view, with no radiographic evidence of unerupted or impacted third molars.

- **Impacted molar** near tooth **#37** (mandibular right first molar): Clear indication of horizontal impaction with limited buccal cortical expansion.
- **Impacted molar** near tooth **#47** (maxillary left first molar): Definitive signs of mesioangular impaction with mild resorption of adjacent alveolar bone.
- **Suspected carious lesion** near tooth **#17** (maxillary left first molar): Areas of concern noted for early interproximal demineralization on the distal aspect of #17.

- **Root canal-treated tooth** near **#24** (mandibular right first premolar) with a well-placed post-core restoration.
 - **Crown restoration** on **#27** (mandibular right second molar) with intact margins and no periapical pathology.
 - **Root canal-treated tooth** on **#27** (same tooth as above), confirmed by the presence of a post-core and crown.
 - **Additional crown** noted on **#24** (mandibular right first premolar) with no signs of fracture or secondary caries.
-

- **Impacted molar near #37** requires clinical evaluation to assess eruption potential and surgical planning.
- **Impacted molar near #47** should be monitored for progressive resorption or infection risk.
- **Suspected caries near #17** warrants proximal radiographic confirmation and early intervention to prevent endodontic compromise.

- Reinforce oral hygiene protocols to minimize caries risk in molar regions (#17, #24, #27).
- Monitor for interproximal plaque accumulation near #17 and #24.

- Schedule 6-month recall for clinical and radiographic reassessment of impacted teeth (#37, #47).
- Referral to oral surgeon for evaluation of surgical removal options for impacted #37 and #47.
- Targeted radiographic imaging (#17) in 3 months to confirm caries progression or resolution.
- Annual review of restorations on #24 and #27 for integrity and marginal fitness.
