Grounding Caption

This localization caption provides multi-dimensional spatial analysis of anatomical structures and pathological findings for this panoramic dental X-ray image, including:

Medical Report

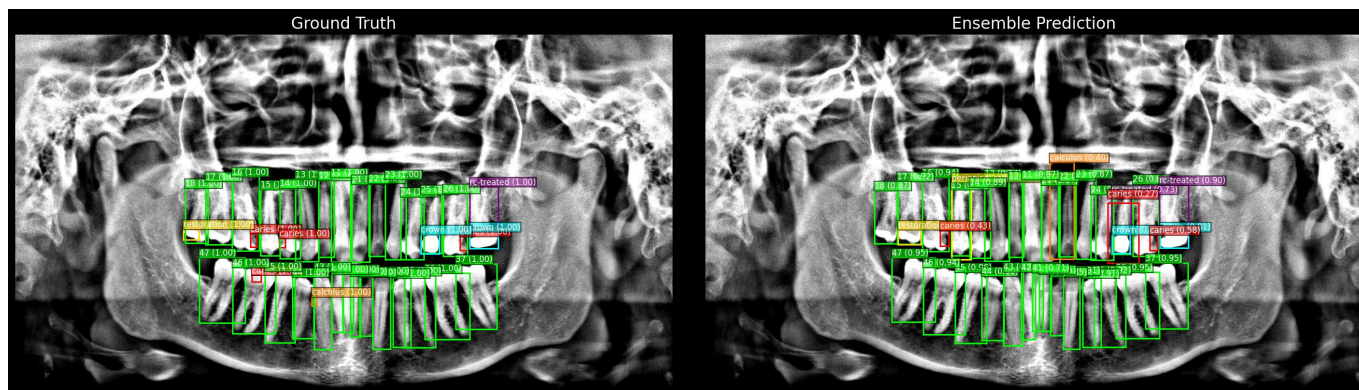
A total of 28 teeth are visualized using FDI numbering. All permanent teeth are present, including the mandibular left first molar (#18), which is unimpacted and fully erupted. No evidence of missing or supernumerary teeth is noted. The dentition demonstrates adequate alignment and normal eruptive patterns.

- #15: Suspicious for periapical radiolucency (score: 0.29).
- #22: Areas of concern noted for calculus (score: 0.4).
- #25: Suspicious for caries (score: 0.27).
- Near #26: Suspicious for caries (score: 0.58).
- Near #15: Suggests caries involvement (score: 0.43).

- #25: Rc-treated tooth with coronal restoration (score: 0.73).
 - Near #26: Rc-treated tooth with crown placement (score: 0.9).
 - Near #26: Presence of a crown (score: 0.81).
 - Near #25: Presence of a crown (score: 0.75).
 - Near #17: Restoration with composite or amalgam (score: 0.69).
-

1. Deep caries suspicious on #25 and near #26 require urgent evaluation for restorative intervention.
2. Periapical radiolucency adjacent to #15 indicates potential endodontic pathology; further diagnostic assessment (e.g., CBCT) is warranted.
3. Calculus deposits on #22 necessitate professional scaling and polishing.

- Reinforce plaque control through biofilm disruption techniques (e.g., interdental brushes, antimicrobial rinses).
- Monitor suspicious caries near #15 and #26 for progression during 3-month recall visits.
- Educate on dietary modifications to reduce cariogenic exposure.

- Schedule 6-month recall for radiographic and clinical reassessment of caries lesions.
- Refer to endodontist for evaluation of #15 periapical radiolucency.
- Address calculus on #22 with prophylaxis and re-evaluate at 3-month interval.
- Consider restorative planning for #25 and #26 within 2 weeks to prevent secondary caries or fracture.
