## Grounding Caption

# Medical Report

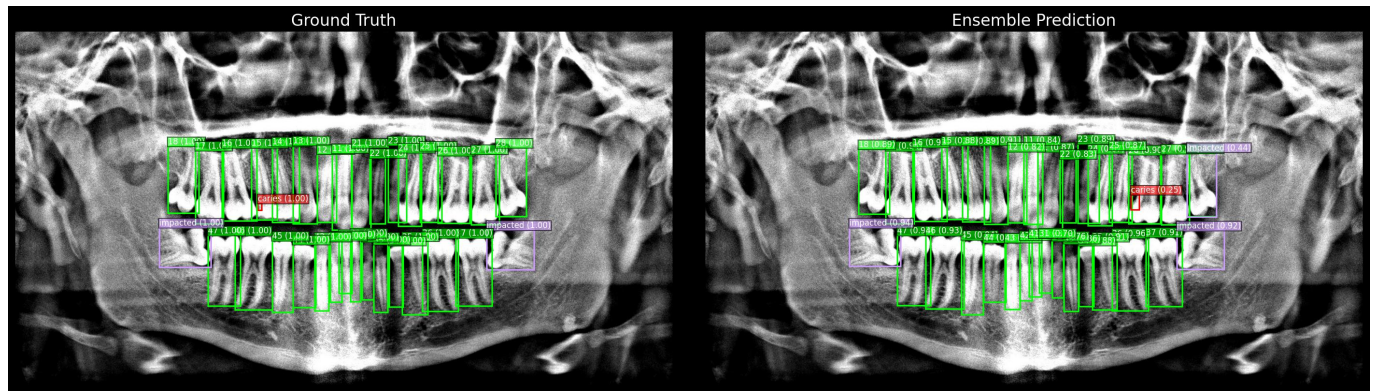
Teeth visibility with center points (total: 30):

Wisdom teeth detection (total: 2):

```
[
{'box_2d': [405, 310, 486, 481], 'tooth_id': '18', 'is_impacted': false, 'score': 0.89},
{'box_2d': [1275, 320, 1353, 488], 'tooth_id': '28', 'is_impacted': true, 'score': 0.63}
]
```

Dental Pathological Findings (total: 4):

```
[
{'box_2d': [1274, 318, 1353, 488], 'tooth_id': '28', 'label': 'impacted', 'score': 0.44},
{'box_2d': [380, 517, 516, 620], 'tooth_id': 'unknown', 'label': 'impacted', 'score': 0.94, 'near_tooth': '47'},
{'box_2d': [1248, 524, 1373, 627], 'tooth_id': 'unknown', 'label': 'impacted', 'score': 0.92, 'near_tooth': '37'},
{'box_2d': [1126, 430, 1148, 470], 'tooth_id': 'unknown', 'label': 'caries', 'score': 0.25, 'near_tooth': '26'}
]
```

A total of 30 visualized teeth are identifiable with high confidence. Wisdom teeth (#18, #28) are present: #18 is fully erupted without impaction, while #28 is impacted. The remaining dentition demonstrates normal anatomical alignment and spatial relationships.

- **#28 (mandibular right third molar)**: Confirmed impacted with radiographic evidence of bony obstruction.
- **Near #47 (mandibular left third molar)**: Sign of impacted tissue adjacent to tooth #47, consistent with partial eruption or bony impaction.
- **Near #37 (mandibular right second molar)**: Similar radiographic pattern suggests adjacent impacted pathology.
- **Near #26 (maxillary left first molar)**: Suspicious radiolucency adjacent to #26 raises concern for early caries or demineralization.

No restorative or endodontic treatments, crowns, or implants are detectable within the visualized field.

- Impacted mandibular right third molar (#28) requires clinical evaluation for potential surgical removal.
- Adjacent impacted regions near #47 and #37 necessitate further imaging (e.g., CBCT) to assess soft tissue involvement and surgical planning.
- Monitor suspicious radiolucency near #26 for progression; definitive diagnosis via supplemental imaging or caries detection aids is warranted.

- Reinforce oral hygiene protocols to mitigate caries risk near suspicious area adjacent to #26.
- Advise patient on dietary modifications and fluoride application to strengthen demineralized regions.
- Educate on signs of pericoronitis related to impacted #28 and #47/#37.

- Referral to oral surgeon for impacted #28 and adjacent #47/#37 within 2 weeks.
- Repeat panoramic imaging in 6 months to assess suspicious area near #26.
- Schedule 3-month recall for clinical correlation and caries monitoring.
