Grounding Caption

Oral Panoramic Radiographic Examination Report

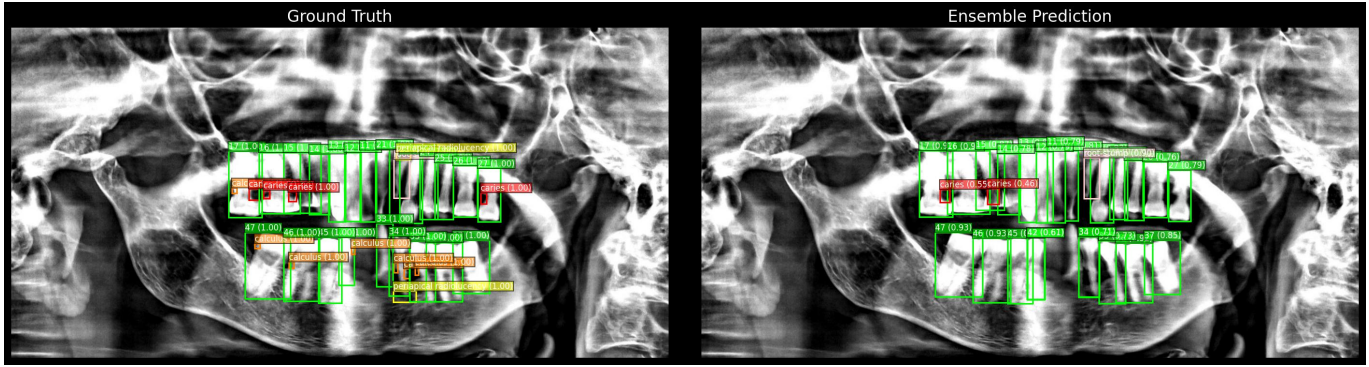
- A total of **23 teeth** are visualized, with no detectable wisdom teeth present.
- Visualized teeth include: #11, #12, #13, #14, #15, #16, #17, #21, #23, #24, #25, #26, #27, #33, #34, #35, #36, #37, #42, #43, #45, #46, #47.

- **Root stump noted near tooth #23**, indicating prior extraction or resorption.
- **Suspected carious lesion near tooth #17**, with limited radiographic clarity suggesting early decay or developmental anomaly.
- **Suspected carious involvement near tooth #15**, areas of concern noted for potential demineralization.

- No restorations, crowns, root canal treatments, or implants identified in the visualized field.
-

- **Root stump near #23** requires evaluation for complete removal or monitoring for infection.
- **Suspected caries near #17 and #15** warrant early intervention to prevent progression.

- Reinforce oral hygiene protocols for interproximal areas of #17 and #15.
- Monitor radiographic areas of concern during routine check-ups for changes in density.

- Schedule **6-month recall** for reassessment of suspected caries and root stump.
 - Refer to general dentist for **detailed evaluation of #17 and #15** to confirm caries and plan restorative care.
 - Consider surgical consultation for **residual root fragment near #23** if clinically symptomatic.
-
