Grounding Caption

Medical Report

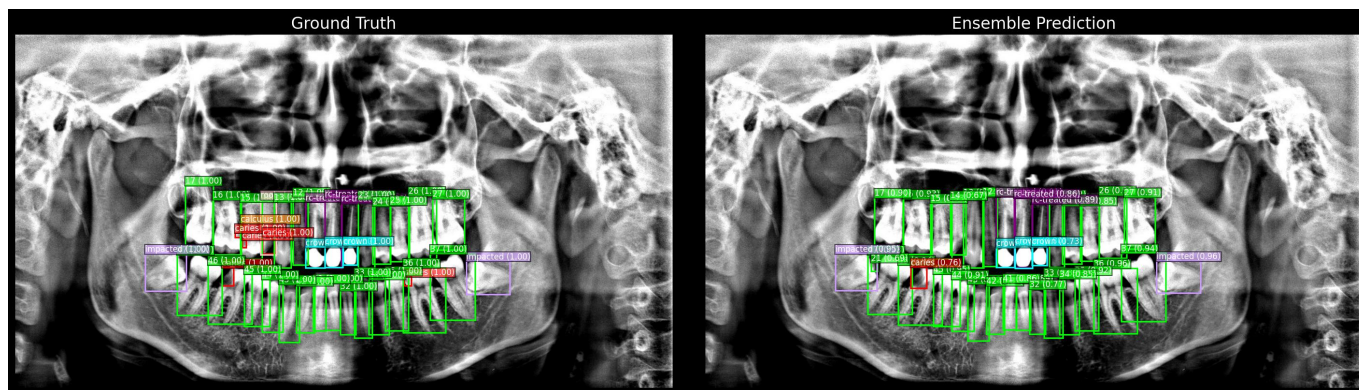
A total of 26 teeth are visualized within the panoramic field. No wisdom teeth (third molars) are present. The dental arches demonstrate normal anatomical alignment, with no evidence of significant resorption or alveolar bone loss.

- Clear indication of impacted teeth near #37 (lower left first molar) and #21 (upper right lateral incisor).
- Suspicious for caries in the interproximal region near #46 (upper left first molar), requiring further evaluation.

- Presence of a crown and root canal-treated tooth at #12 (upper right lateral incisor).
 - Three distinct crowns and two root canal-treated regions noted near #23 (lower left first molar).
-

- Impacted tooth near #37 and #21 requires surgical evaluation for potential extraction or orthodontic intervention.
- Suspicious caries near #46 necessitates early diagnostic confirmation (e.g., IOPA or CBCT) to assess caries depth and treatment planning.

- Reinforce meticulous oral hygiene practices, particularly near #46 and #23, to mitigate secondary caries or periodontal complications.
- Monitor interproximal areas for early caries detection using high-resolution imaging as needed.

- Referral to an oral surgeon for surgical assessment of impacted regions near #37 and #21.
- Schedule a follow-up appointment within 2 weeks for caries evaluation at #46.
- 6-month recall for monitoring restorations at #12 and #23, with annual panoramic imaging for long-term surveillance.
