Grounding Caption

This localization caption provides multi-dimensional spatial analysis of anatomical structures and pathological findings for this panoramic dental X-ray image, including:

Medical Report

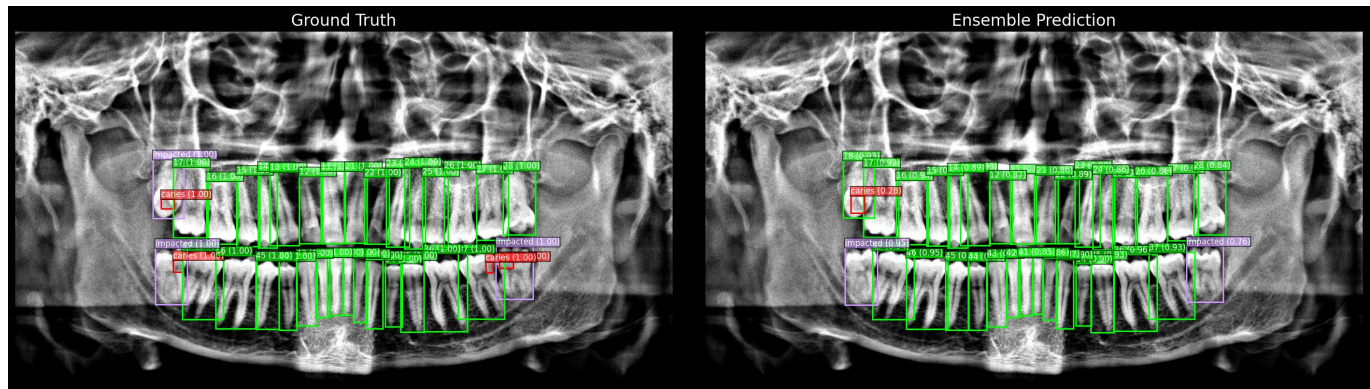
A total of 30 teeth were visualized. Both maxillary wisdom teeth (#18 and #28) are present and not impacted.

- Clear indication of an impacted tooth near #47.
- Suspicious for an impacted lesion near #37.
- Areas of concern noted for suspected carious lesion near #18.

No prior dental treatments (restorations, crowns, root canal therapy, or implants) were identified.

- Impacted tooth near #47 requires surgical evaluation for potential removal.
- Suspicious impacted lesion near #37 warrants further diagnostic imaging (e.g., CBCT) to confirm extent and plan intervention.
- Suspected carious lesion near #18 necessitates clinical correlation and early intervention to prevent progression.

- Reinforce meticulous oral hygiene practices, particularly around #18 and #37.
- Monitor suspicious carious lesion near #18 for radiographic and clinical progression.

- Schedule a 3-month recall for reassessment of the suspicious lesion near #37.
- Refer to an oral surgeon for evaluation and management of the impacted tooth near #47.
- Consider endodontic consultation for #18 if carious involvement is confirmed.
