Grounding Caption

Medical Report

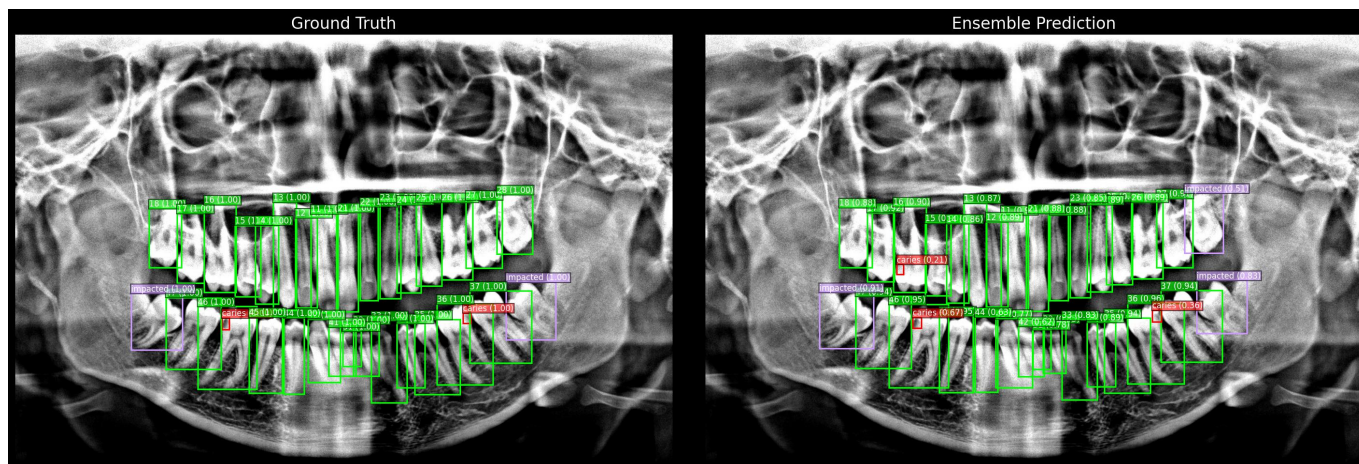
This localization caption provides multi-dimensional spatial analysis of anatomical structures and pathological findings for this panoramic dental X-ray image, including:

Teeth visibility with center points (total: 28):

Dental Pathological Findings (total: 6):

```
[
{'box_2d': [288, 649, 425, 791], 'tooth_id': 'unknown', 'label': 'impacted', 'score': 0.91, 'near_tooth': '47'},
{'box_2d': [1242, 619, 1369, 753], 'tooth_id': 'unknown', 'label': 'impacted', 'score': 0.83, 'near_tooth': '37'},
{'box_2d': [524, 712, 546, 740], 'tooth_id': 'unknown', 'label': 'caries', 'score': 0.67, 'near_tooth': '46'},
{'box_2d': [1211, 399, 1308, 550], 'tooth_id': 'unknown', 'label': 'impacted', 'score': 0.51, 'near_tooth': '27'},
{'box_2d': [1129, 694, 1153, 724], 'tooth_id': 'unknown', 'label': 'caries', 'score': 0.36, 'near_tooth': '36'},
{'box_2d': [483, 579, 500, 604], 'tooth_id': 'unknown', 'label': 'caries', 'score': 0.21, 'near_tooth': '16'}
]
```

The panoramic image visualizes 28 teeth, with no apparent congenital absence noted. Wisdom teeth status reveals the presence of tooth #18 (lower left third molar) in a non-impacted position. The remaining wisdom teeth (e.g., #17, #28, #38) are not visualized, suggesting potential extraction, impaction, or absence. No periodontal disease or significant resorption is observed.

- **Clear indication of impacted tooth near #47** (lower left second molar).
- **Clear indication of impacted tooth near #37** (lower right second molar).
- **Suspected carious lesion near #46** (lower left first molar), requiring confirmation via supplemental imaging.
- **Suspected impacted tooth near #27** (upper right first molar), with equivocal radiographic features.
- **Areas of concern for carious decay near #36** (lower right first molar) and **#16** (upper left first molar), consistent with early demineralization or occlusal decay.

No prior restorations, root canal treatments, crowns, or implants are identified.

- Impacted tooth near **#47** and **#37** requires evaluation for surgical extraction due to risk of infection or malocclusion.
- Suspected carious lesions near **#46**, **#36**, and **#16** necessitate clinical correlation and preventive intervention to prevent progression.

- Reinforce oral hygiene protocols, emphasizing interproximal cleaning for caries-prone areas.
- Monitor areas of suspected calculus (though not explicitly quantified in imaging) through regular prophylaxis.

- **Immediate referral to oral surgeon** for impacted teeth near #47 and #37.
- **3-month recall** for re-evaluation of carious lesions near #46, #36, and #16.
- **6-month panoramic imaging** to assess stability of suspicious caries and impacted teeth.
