Grounding Caption

Oral Panoramic Radiographic Examination Report

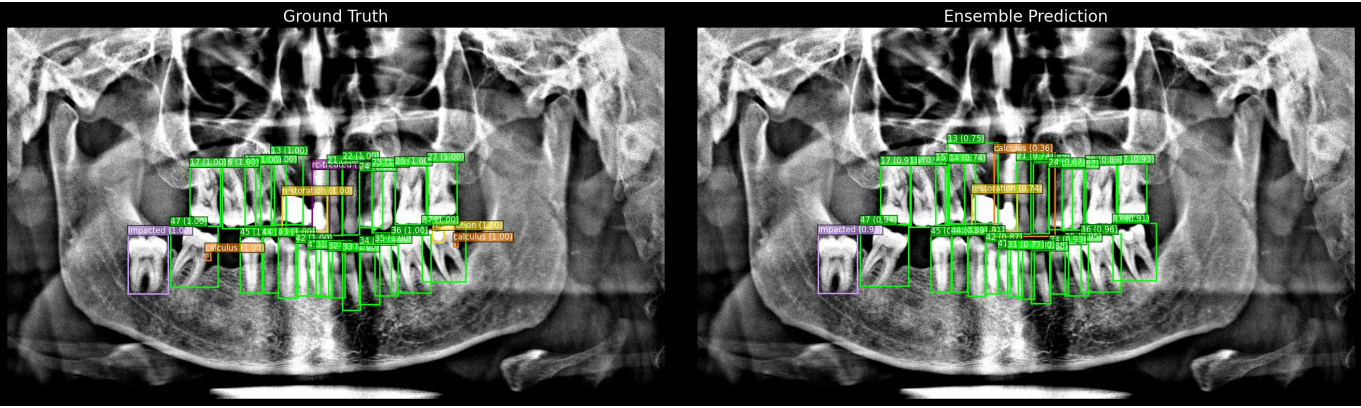
A total of 24 teeth are clearly visualized within the panoramic image. No wisdom teeth (third molars) are present bilaterally. The remaining teeth exhibit varying degrees of alignment and integrity, with no overt signs of severe periodontal or structural compromise.

- **Sign of impacted structure** adjacent to tooth #47 (left maxillary first molar). The finding suggests an adjacent anatomical anomaly or obstruction requiring further evaluation.
- **Suggests possible calculus accumulation** near tooth #21 (left mandibular lateral incisor). The low confidence level indicates a tentative interpretation requiring corroboration through clinical examination.

- **Presence of a restoration** (filling) adjacent to tooth #21. The intervention appears to address prior carious or structural compromise in this region.
-

1. **Impacted structure near #47:** Requires radiographic correlation (e.g., CBCT) to confirm diagnosis and assess adjacent anatomical relationships.
2. **Restoration at #21:** Monitor for secondary caries or marginal integrity issues during routine recalls.

- **Reinforce oral hygiene protocols** near #21 to mitigate calculus risk.
- **Educate on signs of impaction-related complications** (e.g., pain, infection) for early intervention.

- **Referral to oral surgeon** for evaluation of impacted structure near #47.
 - **6-month recall** to reassess calculus near #21 and monitor restoration margins.
 - **Annual panoramic imaging** to track stability of findings and document longitudinal changes.
-
