## Medical Report

### Oral Panoramic Radiographic Report

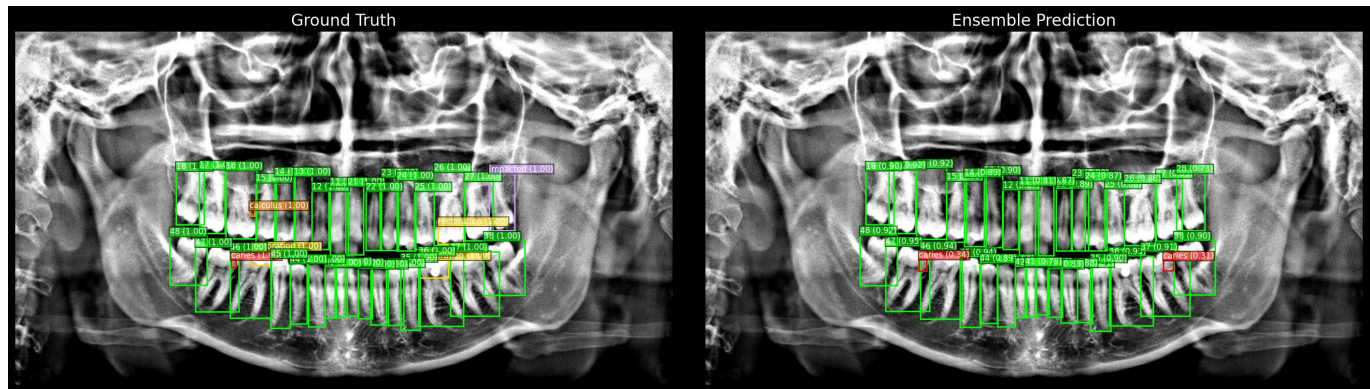
This localization caption provides multi-dimensional spatial analysis of anatomical structures and pathological findings for this panoramic dental X-ray image, including:

```
[
{'box_2d': [409, 538, 507, 671], 'tooth_id': '48', 'is_impacted': false, 'score': 0.92},
{'box_2d': [424, 367, 499, 509], 'tooth_id': '18', 'is_impacted': false, 'score': 0.9},
{'box_2d': [1240, 551, 1348, 695], 'tooth_id': '38', 'is_impacted': false, 'score': 0.9},
{'box_2d': [1246, 373, 1321, 525], 'tooth_id': '28', 'is_impacted': false, 'score': 0.73}
]
```

```
[
{'box_2d': [565, 601, 585, 631], 'tooth_id': 'unknown', 'label': 'caries', 'score': 0.34, 'near_tooth': '47'},
{'box_2d': [1211, 603, 1238, 630], 'tooth_id': 'unknown', 'label': 'caries', 'score': 0.31, 'near_tooth': '37'}
]
```

- **32 teeth** are visualized, including all four third molars (#48, #18, #38, #28).
- All detected wisdom teeth are **present and non-impacted**, with normal eruptive positioning.
- No evidence of systemic pathology or radiographic anomalies in the mandibular or maxillary bone.

- **Suspicious areas suggestive of early caries** noted in proximity to:
  - **#47** (left maxillary first molar).
  - **#37** (right mandibular first molar).
- No radiographic signs of periodontal disease, periapical pathology, or retained roots.

- **No prior dental treatments** (restorations, root canals, crowns, or implants) observed.
-

- **Early caries concerns** near #47 and #37 require clinical correlation via visual examination and possibly supplemental imaging (e.g., bitewing radiographs).
- No urgent impactions or fractures detected; however, wisdom teeth (#28, #38) demonstrate lower confidence scores in localization, warranting closer clinical assessment.

- Reinforce oral hygiene protocols, emphasizing interproximal cleaning (flossing, water flossing) for #47 and #37.
- Monitor for progression of suspicious carious lesions during routine follow-ups.

- **Schedule a 3-month recall** to reassess radiographic changes in #47 and #37.
  - **Referral to general dentist** for definitive evaluation of caries, including possible restorative intervention.
  - Continue 6-month recall program for routine panoramic review and periodontal screening.
-
