Grounding Caption

ORAL PANORAMIC X-RAY EXAMINATION REPORT

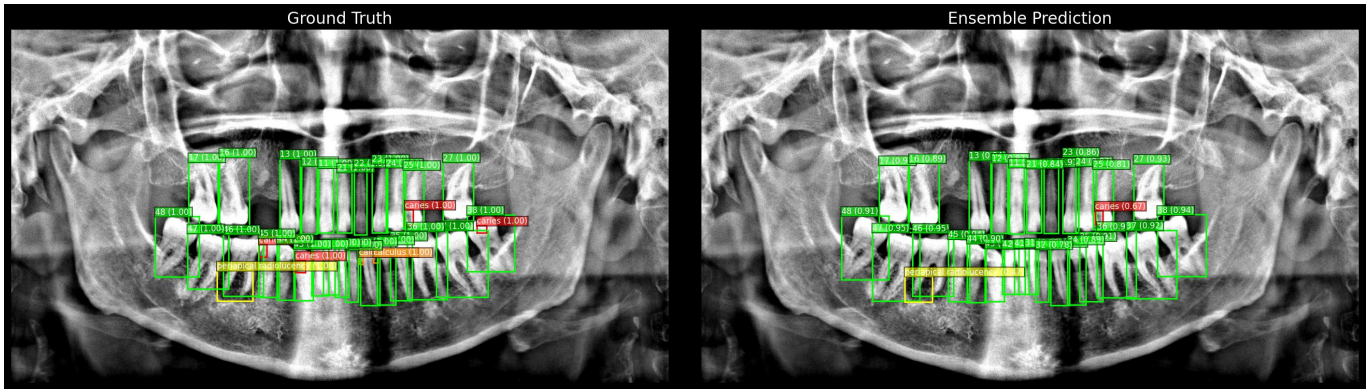
A total of 27 teeth are visualized, including both upper and lower wisdom teeth (#38 and #48). The wisdom teeth are fully erupted and not impacted. No evidence of missing or supernumerary teeth is noted.

- **Caries:** Areas of concern are noted suspicious for caries near tooth #25 (left second molar).
- **Periapical Radiolucency:** A suspicious radiolucent area is observed near tooth #46 (left first molar), potentially indicating periapical pathology.

No restorations, crowns, root canal treatments, or implants are observed in the examined teeth.

1. **Caries Risk:** The suspicious caries near #25 requires immediate evaluation to confirm presence and extent.
2. **Periapical Radiolucency:** The radiolucent lesion near #46 warrants investigation for possible apical periodontitis or other periapical pathology.

- Reinforce oral hygiene practices, emphasizing interdental cleaning for #25 and #46.
- Monitor caries-susceptible areas during routine check-ups.

- Schedule a 6-month recall for reassessment of findings.
 - Refer to an endodontist for advanced imaging (e.g., CBCT) and treatment planning for the periapical radiolucency near #46.
 - Recommend a dental cleaning session to address potential biofilm accumulation in posterior regions.
-
