## Grounding Caption

# Medical Report

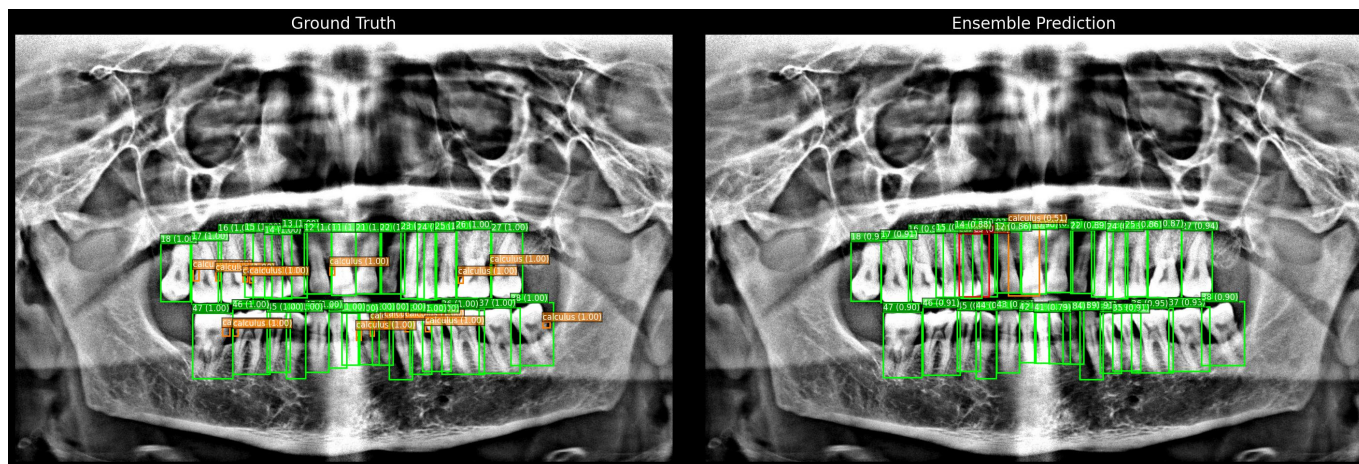
A total of 30 teeth were visualized. Wisdom teeth (#18 and #38) are present and not impacted. Overall dental alignment and spacing appear within normal limits, with no evident fractures or gross radiographic abnormalities noted.

- #13 (left lateral incisor): Areas of concern noted for suspected caries, with radiographic shadowing in the cervical region.
- #11 (right lateral incisor): Suspicious for calculus deposition in the apical region, consistent with soft tissue shadowing.

- Suspected caries on #13 requires clinical correlation for definitive diagnosis.
- Radiographic shadowing near #11 raises concern for calculus accumulation, necessitating periodontal evaluation.

- Reinforce plaque control through biofilm removal techniques and interdental brushing.
- Emphasize dietary counseling to limit cariogenic exposure, particularly for #13.

- Schedule a 3-month recall for intraoral examination and confirmation of caries status on #13.
- Perform periodontal probing to assess calculus on #11 and initiate scaling if confirmed.
- Consider bite-wing radiographs for supplemental assessment of interproximal caries in the anterior region.
