## Grounding Caption

## Medical Report

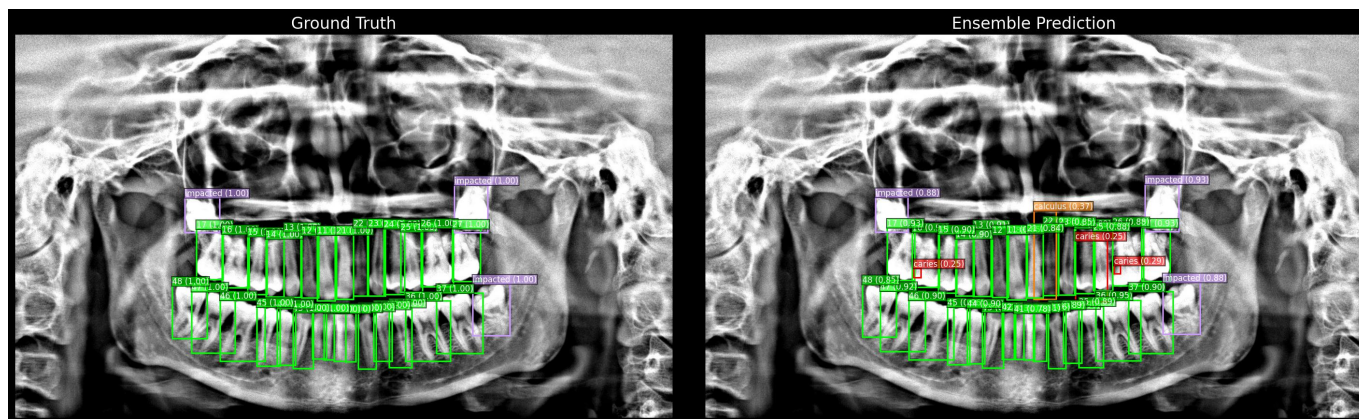
This localization caption provides multi-dimensional spatial analysis of anatomical structures and pathological findings for this panoramic dental X-ray image, including:

A total of 29 teeth are visualized, with all permanent teeth accounted for except #48 (right lower third molar), which is present and unimpacted. Wisdom teeth (#48) are fully erupted and anatomically normal. No evidence of recent tooth extraction or extensive periodontal bone loss is observed.

- #24 (Left Lower First Premolar):** Suspicious for caries noted in the proximal surface.
- #22 (Right Lower Second Premolar):** Suggests calculus deposition near the interproximal area.
- Near #27 (Right Lower Second Molar):** Clear indication of impacted bone spicules or radiopaque structures adjacent to the apical region.
- Near #17 (Left Lower Second Molar):** Shows evidence of impacted radiopaque material lateral to the root apices.
- Near #37 (Right Lower Second Molar):** Demonstrates impacted radiopaque structures posterolateral to the tooth.
- Near #25 (Right Lower First Molar):** Areas of concern for caries near the distal surface.
- Near #16 (Left Lower First Molar):** Suspected caries adjacent to the mesial surface.

No prior restorations, crowns, root canal treatments, or implants are identified.

- Impacted radiopaque structures near #27, #17, and #37 require further evaluation to rule out foreign bodies or developmental anomalies.
- Suspected caries on #24 and #25 necessitate confirmation with supplemental imaging or clinical correlation.
- Calculus near #22 indicates localized plaque accumulation and potential periodontal risk.

- Reinforce interdental cleaning techniques (flossing/fixed dental flossers) for high-risk areas (#24, #25, #22).
- Monitor calculus near #22 for progression and associated gingival changes.
- Educate on dietary modifications to reduce caries risk in suspicious areas.

- **6-month recall** for re-evaluation of impacted structures near #27, #17, and #37.
- **Referral to periodontist** for calculus management on #22.
- **Consider CBCT imaging** for precise localization of impacted radiopaque material.
- **Dental caries confirmation** via visual inspection and/or bitewing radiographs for #24 and #25.
