## Grounding Caption

# Medical Report

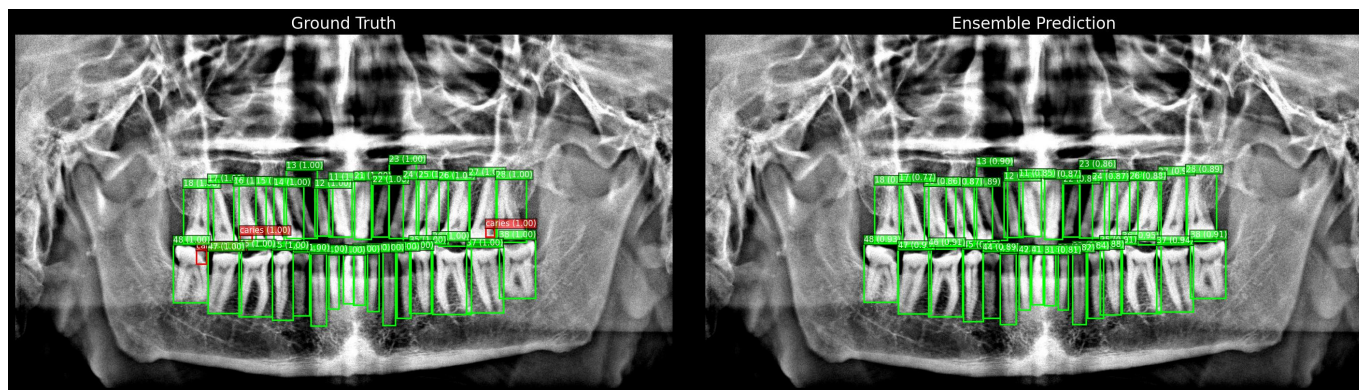
This localization caption provides multi-dimensional spatial analysis of anatomical structures and pathological findings for this panoramic dental X-ray image, including:

Teeth visibility with center points (total: 32):

Wisdom teeth detection (total: 4):

```
[
{'box_2d': [419, 552, 509, 706], 'tooth_id': '48', 'is_impacted': false, 'score': 0.93},
{'box_2d': [1283, 539, 1376, 696], 'tooth_id': '38', 'is_impacted': false, 'score': 0.91},
{'box_2d': [447, 395, 521, 550], 'tooth_id': '18', 'is_impacted': false, 'score': 0.89},
{'box_2d': [1272, 367, 1352, 546], 'tooth_id': '28', 'is_impacted': false, 'score': 0.89}
]
```

The panoramic radiograph visualizes a full complement of 32 teeth, including all four wisdom teeth (#18, #28, #38, #48). All detected wisdom teeth demonstrate normal eruption without signs of impaction or displacement.

No significant pathological findings are evident on the radiographic examination.

No prior restorative, endodontic, or prosthetic interventions are identified.

No urgent dental pathologies or treatment requirements are observed.

Emphasize routine oral hygiene practices, including plaque control and regular professional scaling to prevent periodontal and carious lesions.

Schedule a 6-month recall for routine monitoring of dental health. Maintain annual panoramic imaging for longitudinal assessment of anatomical stability and early detection of emerging pathologies.
