Grounding Caption

ORAL PANORAMIC X-RAY EXAMINATION REPORT

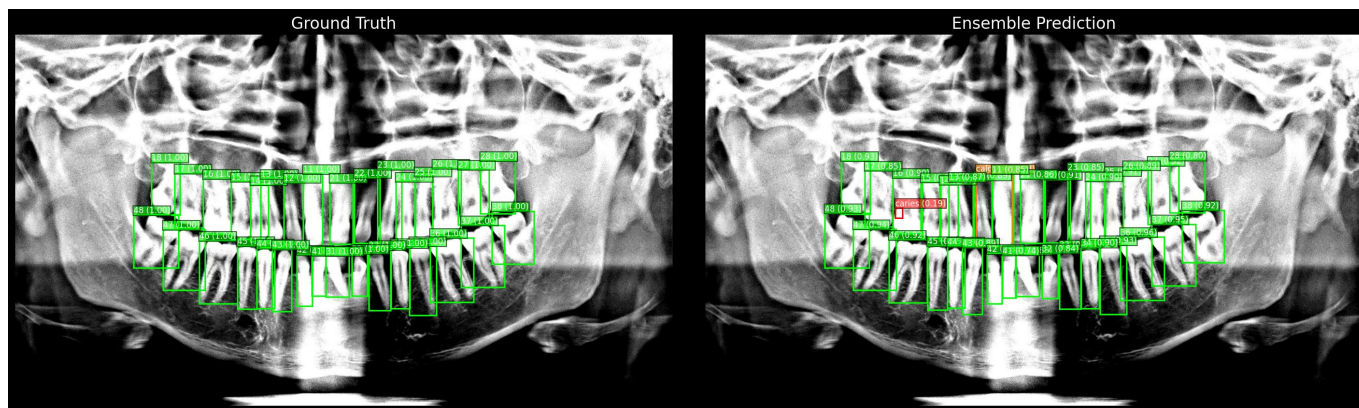
```
[
  {'box_2d': [709, 363, 804, 551], 'tooth_id': '12', 'label': 'calculus', 'score': 0.38},
  {'box_2d': [498, 454, 517, 479], 'tooth_id': 'unknown', 'label': 'caries', 'score': 0.19, 'near_tooth': '16'}
]
```

A total of 32 teeth are visualized, with all anatomical structures and dental crowns fully erupted. All four wisdom teeth (#18, #28, #38, #48) are present and not impacted.

- **Tooth #12 (FDI 12):** Suspected calculus deposition noted at the root apices, with radiopaque density changes.
- **Area near tooth #16 (FDI 16):** Areas of concern for early carious lesion identified lateral to the mesial root, consistent with a small radiolucent shadow.

1. **Suspected calculus on #12:** Requires further clinical evaluation to confirm presence and extent.
2. **Caries suspicion near #16:** Early carious involvement warrants close monitoring to prevent progression.

- Reinforce biofilm control through improved interproximal brushing and flossing techniques.
- Schedule professional scaling for suspected calculus on #12 to mitigate periodontal risk.

- **Referral to periodontist:** For assessment of calculus on #12 and potential instrumentation.
 - **6-month recall:** To reassess the carious lesion near #16 using clinical and radiographic correlation.
 - **Oral hygiene counseling:** Focus on high-risk areas, including the mesial aspect of #16.
-
