## Grounding Caption

### Oral Panoramic Radiographic Examination Report

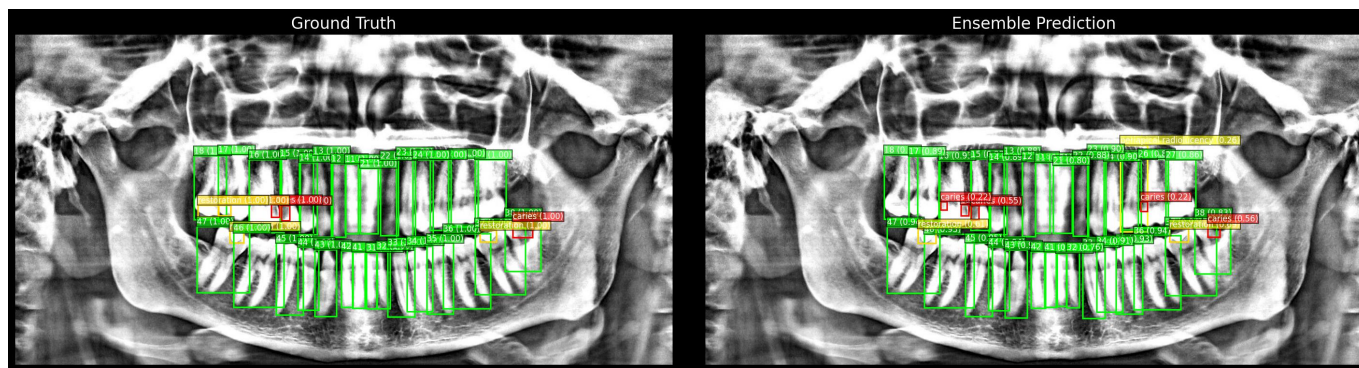
```
[
  {'box_2d': [896, 238, 955, 425], 'tooth_id': '25', 'label': 'periapical radiolucency', 'score': 0.26},
  {'box_2d': [552, 366, 568, 390], 'tooth_id': 'unknown', 'label': 'caries', 'score': 0.7, 'near_tooth': '16'},
  {'box_2d': [1084, 406, 1110, 436], 'tooth_id': 'unknown', 'label': 'caries', 'score': 0.56, 'near_tooth': '38'},
  {'box_2d': [574, 369, 590, 399], 'tooth_id': 'unknown', 'label': 'caries', 'score': 0.55, 'near_tooth': '15'},
  {'box_2d': [508, 360, 521, 378], 'tooth_id': 'unknown', 'label': 'caries', 'score': 0.22, 'near_tooth': '16'},
  {'box_2d': [939, 360, 954, 380], 'tooth_id': 'unknown', 'label': 'caries', 'score': 0.22, 'near_tooth': '26'}
]
```

- **Total teeth visualized:** 30 teeth identified across the dental arch, with full dentition apparent.
- **Wisdom teeth status:**
- #18 (left mandibular third molar) and #38 (right maxillary third molar) are present and unimpacted.

- **Periapical radiolucency:** An area of concern noted at the apical region of #25 (right mandibular first molar).
- **Suspected caries:**
- Suspicious for carious lesion near #15 (left mandibular lateral incisor).
- Area of concern for caries near #16 (left mandibular canine).
- Suspected carious involvement near #26 (right maxillary first molar).
- Areas of concern for caries near #37 (left mandibular first molar) and #38 (right maxillary third molar).

- **Restorations:**
  - Presence of a restoration adjacent to #37 (left mandibular first molar).
  - Restoration detected near #47 (left maxillary second molar).
-

1. **Periapical radiolucency at #25** requires endodontic evaluation to rule out apical periodontitis or abscess.
2. **Suspected caries near #15, #16, #26, #37, and #38** demand immediate clinical correlation and preventive intervention.

- Reinforce oral hygiene protocols, emphasizing interproximal cleaning for at-risk areas.
- Monitor suspicious regions for caries progression during routine follow-ups.

- **6-month recall** for radiographic reassessment of periapical lesion at #25 and carious lesions.
  - **Referral to endodontist** for #25 if clinical symptoms (e.g., pain, swelling) emerge.
  - **Dental caries management** for high-risk sites via fluoride application or sealants as clinically indicated.
-
