Grounding Caption

This localization caption provides multi-dimensional spatial analysis of anatomical structures and pathological findings for this panoramic dental X-ray image, including:

Medical Report

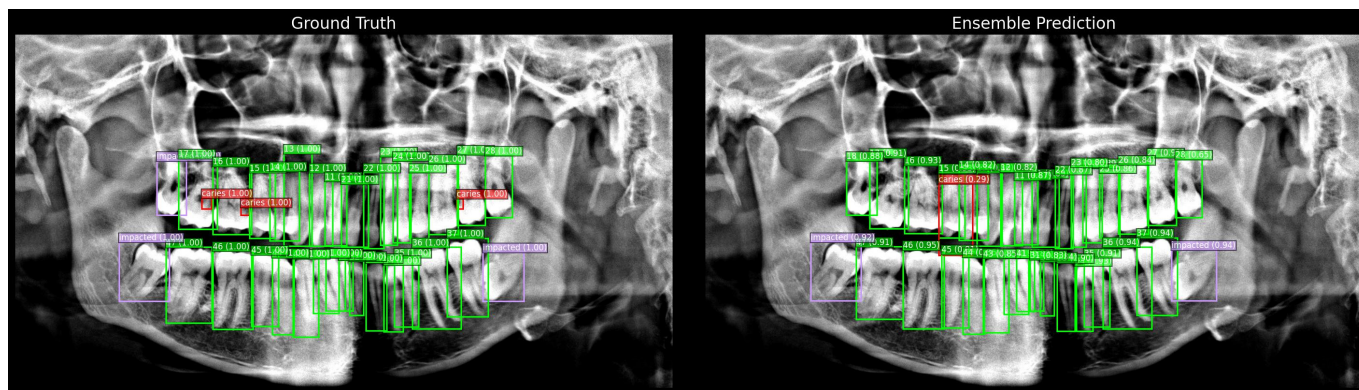
```
[
{'box_2d': [617, 393, 706, 582], 'tooth_id': '15', 'label': 'caries', 'score': 0.29},
{'box_2d': [1233, 568, 1353, 702], 'tooth_id': 'unknown', 'label': 'impacted', 'score': 0.94, 'near_tooth': '37'},
{'box_2d': [278, 547, 411, 702], 'tooth_id': 'unknown', 'label': 'impacted', 'score': 0.92, 'near_tooth': '47'}
]
```

A total of 30 teeth are visualized. All wisdom teeth (tooth #18 and #28) are present and erupted without evidence of impaction.

- **Tooth #15:** Suspicious for caries with an area of radiolucency noted.
- **Near tooth #37:** Clear indication of an impacted tooth adjacent to the region.
- **Near tooth #47:** Clear indication of an impacted tooth adjacent to the region.

- Impacted tooth near #37 and #47 requires clinical evaluation to assess treatment options.
- Suspected caries on #15 necessitates further diagnostic confirmation and intervention planning.

- Reinforce meticulous oral hygiene practices to prevent caries progression.
- Monitor areas of concern (e.g., impacted teeth) for signs of infection or resorption.

- Schedule a 3-month recall for re-evaluation of #15 caries.
- Refer to an oral surgeon for surgical consultation regarding impacted teeth near #37 and #47.
- Recommend panoramic review in 6 months to assess stability of unaddressed findings.
