## Grounding Caption

# Medical Report

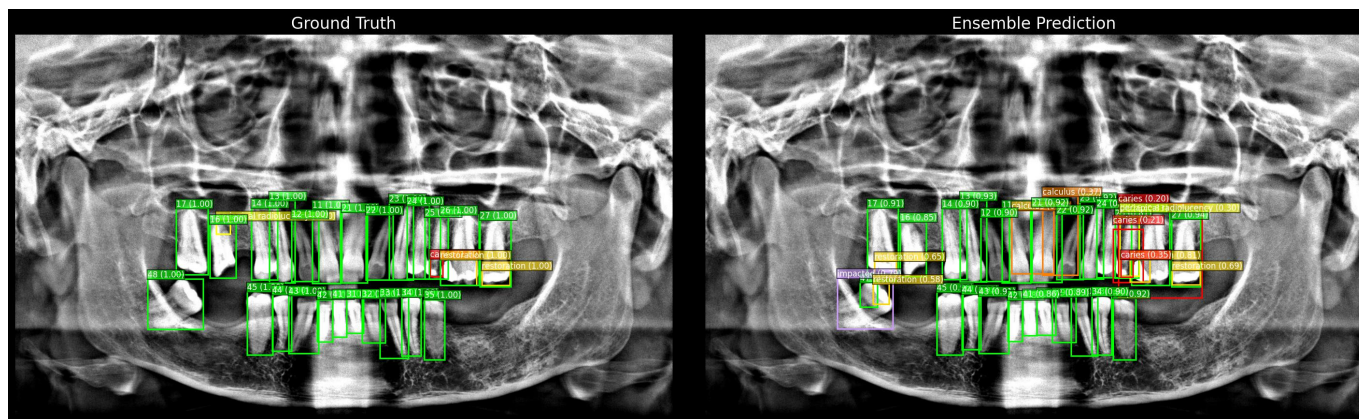
This localization caption provides multi-dimensional spatial analysis of anatomical structures and pathological findings for this panoramic dental X-ray image, including:

A total of 24 teeth are visualized within the panoramic field. No wisdom teeth (third molars) are visible bilaterally. The majority of anterior and posterior teeth demonstrate normal anatomical alignment and root morphology.

- #11: Suspected calculus accumulation noted.
- #22: Areas of concern for calculus deposits.
- #25: Periapical radiolucency and suspicious carious lesion identified.
- #26: Suspicious for caries and adjacent restoration requiring evaluation.
- Near #47: Radiographic evidence of impacted tooth.
- Near #25: Secondary suspicious carious lesion detected.

- Near #17, #26, #27, and #47: Presence of prior restorative interventions confirmed.
-

- Impacted anatomical structure near #47 requires surgical assessment for removal.
- Periapical radiolucency on #25 warrants endodontic evaluation to rule out apical periodontitis.
- Carious lesions on #25 and #26 necessitate prompt restorative treatment.

- Reinforce oral hygiene protocols targeting interproximal plaque control, particularly for #11 and #22.
- Monitor radiographic changes in #25 and adjacent restorations during 6-month follow-ups.

- Schedule urgent referral to oral surgeon for impacted tooth near #47.
  - Arrange endodontic consultation for #25 within 2 weeks.
  - Recare appointment in 6 months for comprehensive re-evaluation of caries progression and periapical healing.
-
