Grounding Caption

This localization caption provides multi-dimensional spatial analysis of anatomical structures and pathological findings for this panoramic dental X-ray image, including:

Medical Report

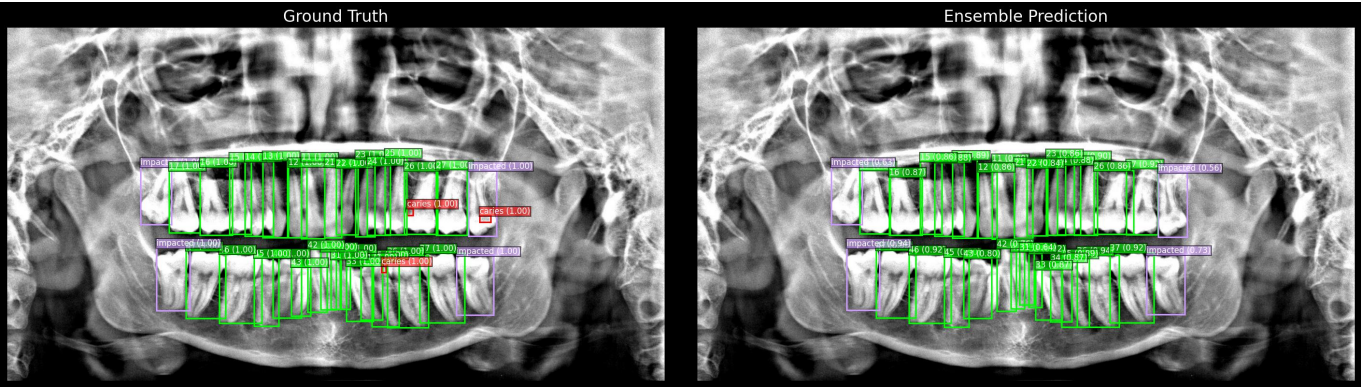
```
[
  {'box_2d': [394, 581, 482, 746], 'tooth_id': 'unknown', 'label': 'impacted', 'score': 0.94, 'near_tooth': '47'},
  {'box_2d': [1188, 600, 1289, 758], 'tooth_id': 'unknown', 'label': 'impacted', 'score': 0.73, 'near_tooth': '37'},
  {'box_2d': [353, 367, 436, 520], 'tooth_id': 'unknown', 'label': 'impacted', 'score': 0.63, 'near_tooth': '17'},
  {'box_2d': [1219, 383, 1296, 553], 'tooth_id': 'unknown', 'label': 'impacted', 'score': 0.56, 'near_tooth': '27'}
]
```

- A total of 27 teeth are visualized, with no evidence of wisdom teeth.
- All detected teeth are anatomically present and positioned within the expected range for normal eruption.

- **#47 (right lower first molar):** Clear indication of an impacted tooth near #47.
- **#37 (left lower first molar):** Suspicious for impacted tooth near #37, requiring further evaluation.
- **#17 (right upper first molar):** Suggests impacted tooth near #17; low-confidence finding necessitates clinical correlation.
- **#27 (left upper first molar):** Areas of concern noted for potential impacted tooth near #27, with equivocal radiographic appearance.

- No restorations, crowns, root canal treatments, or implants are observed.
-

- **Impacted tooth near #47:** Requires urgent evaluation to assess for angulation, space availability, and potential complications (e.g., cyst formation, adjacent root resorption).
- **Suspected impacted teeth near #37, #17, and #27:** Monitor for signs of impaction progression or secondary pathology.

- Reinforce patient education on meticulous interproximal cleaning to mitigate caries risk in impacted areas.
- Advise periodic radiographic monitoring (e.g., cone beam CT) to clarify ambiguous findings near #17 and #27.

- **Referral to oral surgeon:** Immediate consultation for impacted #47 to determine extraction viability.
- **6-month recall:** Repeat panoramic imaging to reassess suspicious areas near #37, #17, and #27.
- **Oral hygiene reinforcement:** Schedule professional scaling and polishing to address potential biofilm accumulation near impacted regions.
