Grounding Caption

This localization caption provides multi-dimensional spatial analysis of anatomical structures and pathological findings for this panoramic dental X-ray image, including:

Medical Report

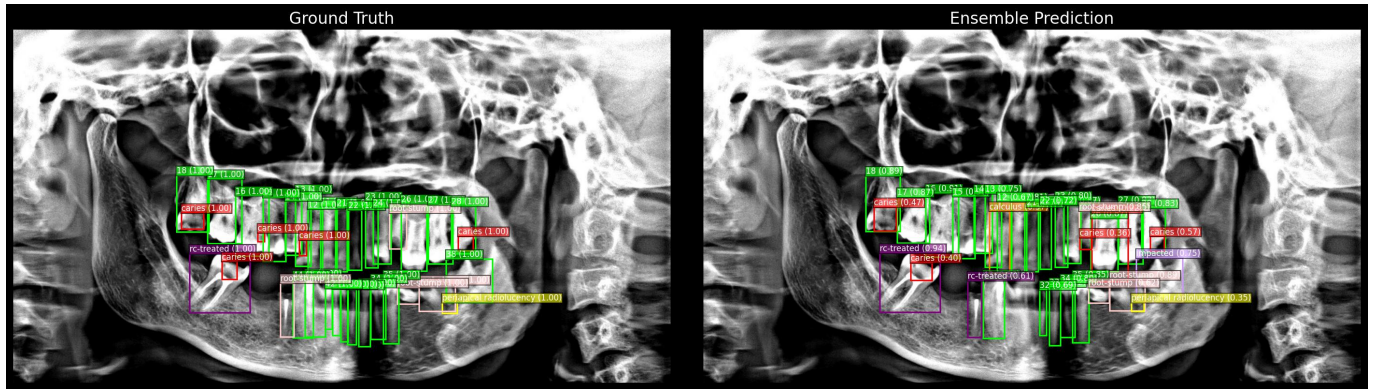
Teeth visibility with center points (total: 20):

```
[
{'point_2d': [1130, 540], 'tooth_id': '27', 'score': 0.93},
{'point_2d': [631, 515], 'tooth_id': '16', 'score': 0.91},
{'point_2d': [689, 522], 'tooth_id': '15', 'score': 0.9},
{'point_2d': [474, 459], 'tooth_id': '18', 'score': 0.89},
{'point_2d': [555, 502], 'tooth_id': '17', 'score': 0.87},
{'point_2d': [976, 540], 'tooth_id': '24', 'score': 0.87},
{'point_2d': [1061, 568], 'tooth_id': '26', 'score': 0.87},
{'point_2d': [768, 737], 'tooth_id': '43', 'score': 0.86},
{'point_2d': [998, 742], 'tooth_id': '35', 'score': 0.85},
{'point_2d': [1191, 530], 'tooth_id': '28', 'score': 0.83},
{'point_2d': [930, 756], 'tooth_id': '33', 'score': 0.82},
{'point_2d': [831, 547], 'tooth_id': '11', 'score': 0.81},
{'point_2d': [947, 538], 'tooth_id': '23', 'score': 0.8},
{'point_2d': [964, 740], 'tooth_id': '34', 'score': 0.8},
{'point_2d': [740, 511], 'tooth_id': '14', 'score': 0.77},
{'point_2d': [766, 530], 'tooth_id': '13', 'score': 0.75},

{'point_2d': [870, 554], 'tooth_id': '21', 'score': 0.74},
{'point_2d': [905, 547], 'tooth_id': '22', 'score': 0.72},
{'point_2d': [898, 747], 'tooth_id': '32', 'score': 0.69},
{'point_2d': [796, 546], 'tooth_id': '12', 'score': 0.67}
]
```

Wisdom teeth detection (total: 2):

```
[
{'box_2d': [429, 385, 519, 532], 'tooth_id': '18', 'is_impacted': false, 'score': 0.89},
{'box_2d': [1160, 471, 1222, 589], 'tooth_id': '28', 'is_impacted': false, 'score': 0.83}
]
```

Dental Pathological Findings (total: 11):

```
[
{'box_2d': [1027, 484, 1124, 666], 'tooth_id': '26', 'label': 'caries', 'score': 0.22},
{'box_2d': [756, 479, 810, 642], 'tooth_id': '13', 'label': 'calculus', 'score': 0.37},
{'box_2d': [1074, 660, 1168, 742], 'tooth_id': 'unknown', 'label': 'root-stump', 'score': 0.89, 'near_tooth': '35'},
{'box_2d': [995, 479, 1041, 580], 'tooth_id': 'unknown', 'label': 'root-stump', 'score': 0.85, 'near_tooth': '24'},
{'box_2d': [1145, 602, 1268, 718], 'tooth_id': 'unknown', 'label': 'impacted', 'score': 0.75, 'near_tooth': '28'},
{'box_2d': [1019, 680, 1074, 722], 'tooth_id': 'unknown', 'label': 'root-stump', 'score': 0.62, 'near_tooth': '35'},
{'box_2d': [1182, 545, 1219, 584], 'tooth_id': 'unknown', 'label': 'caries', 'score': 0.57, 'near_tooth': '28'},
{'box_2d': [451, 468, 510, 531], 'tooth_id': 'unknown', 'label': 'caries', 'score': 0.47, 'near_tooth': '18'},
{'box_2d': [548, 615, 604, 662], 'tooth_id': 'unknown', 'label': 'caries', 'score': 0.4, 'near_tooth': '16'},

{'box_2d': [996, 549, 1026, 579], 'tooth_id': 'unknown', 'label': 'caries', 'score': 0.36, 'near_tooth': '24'},
{'box_2d': [1132, 720, 1165, 744], 'tooth_id': 'unknown', 'label': 'periapical radiolucency', 'score': 0.35, 'near_tooth': '35'}
]
```

Historical Treatments (total: 2):

```
[
{'box_2d': [467, 589, 626, 746], 'tooth_id': 'unknown', 'label': 'rc-treated', 'score': 0.94, 'near_tooth': '17'},
{'box_2d': [699, 663, 735, 813], 'tooth_id': 'unknown', 'label': 'rc-treated', 'score': 0.61, 'near_tooth': '43'}
]
```

A total of 20 teeth were visualized, including the mandibular right first molar (#26) and maxillary left second premolar (#15) with high confidence. Wisdom teeth (#18 and #28) are present and unimpacted.

- **#26:** Suspicious for caries.
- **#13:** Suspicious for calculus.
- **Near #35:** Clear indication of a root stump.
- **Near #24:** Clear indication of a root stump.
- **Near #28:** Suspicious for impacted tooth fragment.
- **Near #28:** Suspicious for caries.
- **Near #18:** Suspicious for caries.
- **Near #16:** Suspicious for caries.
- **Near #24:** Suspicious for caries.
- **Near #35:** Suspicious for periapical radiolucency.

- Root canal-treated tooth noted near #17.
 - Root canal-treated tooth noted near #43.
-

- Root stumps near #35 and #24 require extraction evaluation.
- Suspected impacted fragment near #28 should be assessed for surgical removal.
- Caries on #26 and near #28, #18, #16, and #24 demand prompt intervention to prevent progression.
- Periapical radiolucency near #35 warrants investigation for apical pathology or residual infection.

- Reinforce oral hygiene protocols, emphasizing interdental cleaning for calculus-prone areas (#13).
- Monitor suspicious caries (near #18, #16, #24) for radiographic progression during follow-up.

- Schedule a 6-month recall for reassessment of suspicious caries and calculus.
- Refer to endodontist for #26 and #35 to evaluate periapical radiolucency.
- Consult oral surgeon for impacted fragment near #28 and root stumps near #35/#24.
- Recheck #43 rc-treated tooth for long-term success if symptoms arise.
