Grounding Caption

This localization caption provides multi-dimensional spatial analysis of anatomical structures and pathological findings for this panoramic dental X-ray image, including:

Medical Report

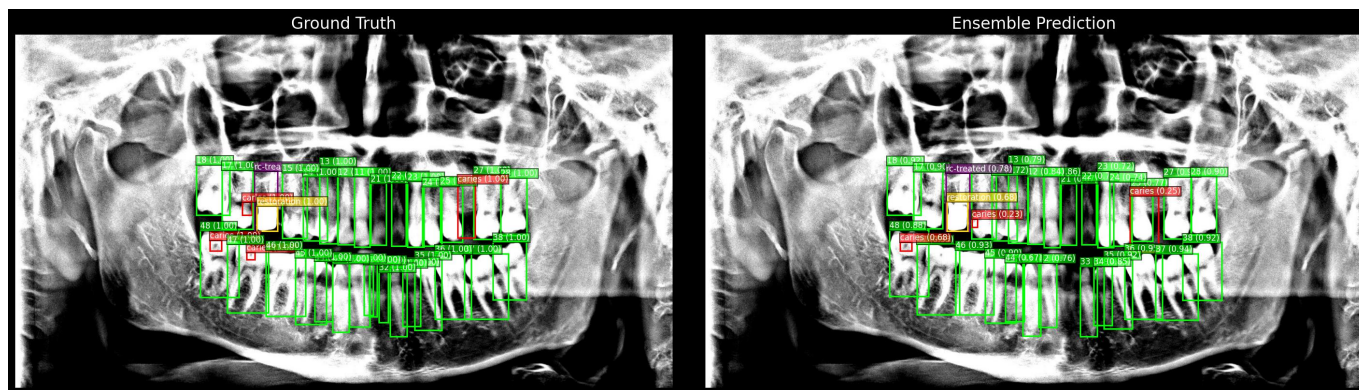
- A total of 27 teeth are visualized within the panoramic field. All four wisdom teeth (#18, #28, #38, #48) are present and non-impacted.
- The remaining dentition shows no evidence of significant anatomical anomalies or fractures.

- **Tooth #25:** Suspicious for caries on the occlusal surface.
- **Near tooth #48:** Suspected caries in a radiolucent lesion adjacent to the distal aspect.
- **Near tooth #15:** Area of concern for caries near the mesial surface.

- **Near tooth #15:** Evidence of a root canal-treated tooth and a composite restoration.
-

- Immediate evaluation of suspicious caries on #25 and near #48 (#48) is required to confirm pathology and initiate preventive or restorative care.
- Monitoring of the area near #15 for secondary caries or restoration failure is advised.

- Strengthen oral hygiene protocols, emphasizing interdental cleaning for #25 and #48.
- Reinforce dietary counseling to minimize cariogenic risk.

- Schedule a 3-month recall for reassessment of caries on #25 and near #48.
- Refer to a general dentist for clinical evaluation of the restoration near #15 and to determine if retreatment is warranted.
- Annual panoramic imaging is recommended for baseline surveillance.
